### Seismic performance of steel-reinforced concrete composite columns of older and modern construction

**Seismic Performance of Steel-Reinforced concrete Composite  
Columns of Older and Modern Construction**

**Masters of Science in Construction Engineering**

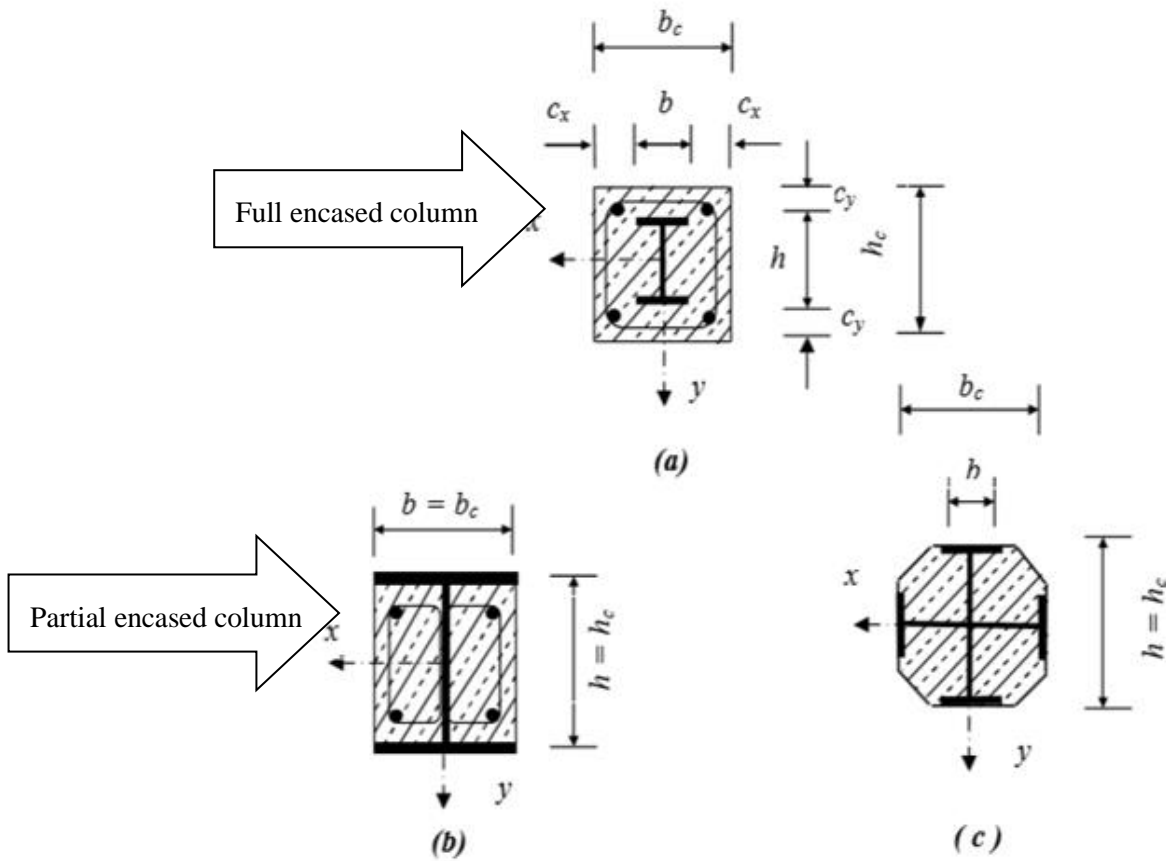
Figure 2.1: Typical cross-sections of fully and partially concrete encased columns

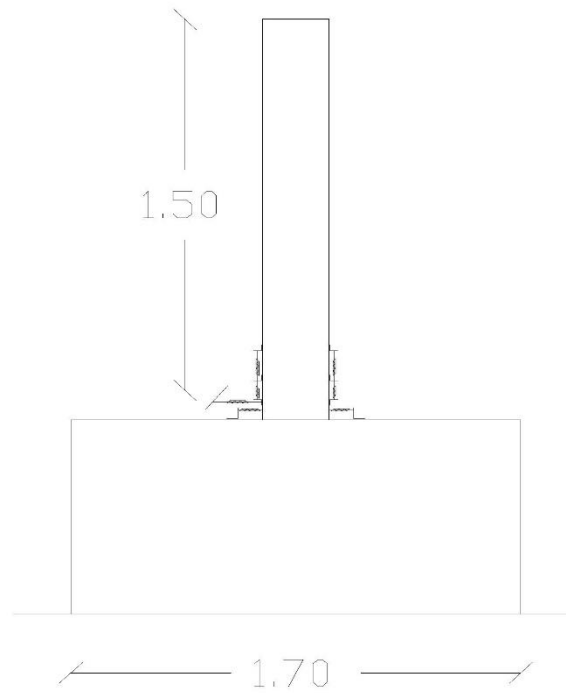
**Figure 4.3: Modern building test specimen external instrumentation**

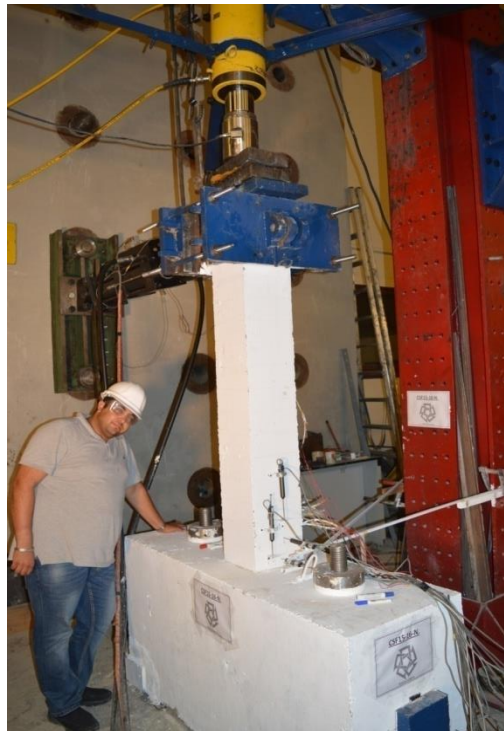
**Figure 4.9: Modern building test specimen arrangement of LVDT**

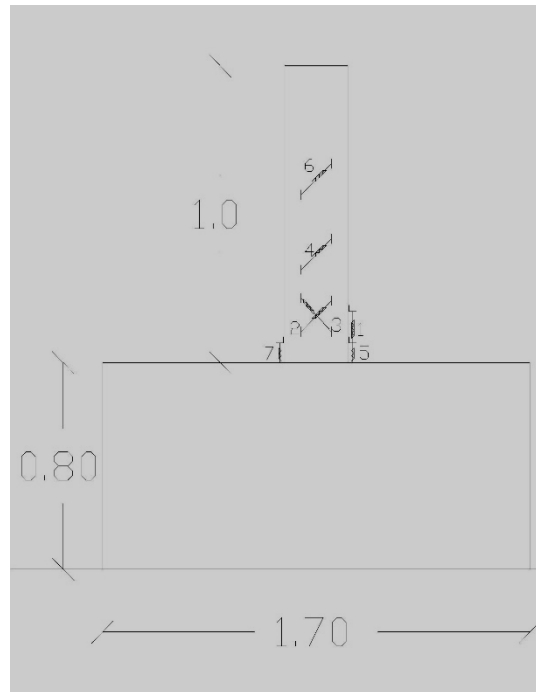
**Figure 4.11: Existing building test specimen external instruments**

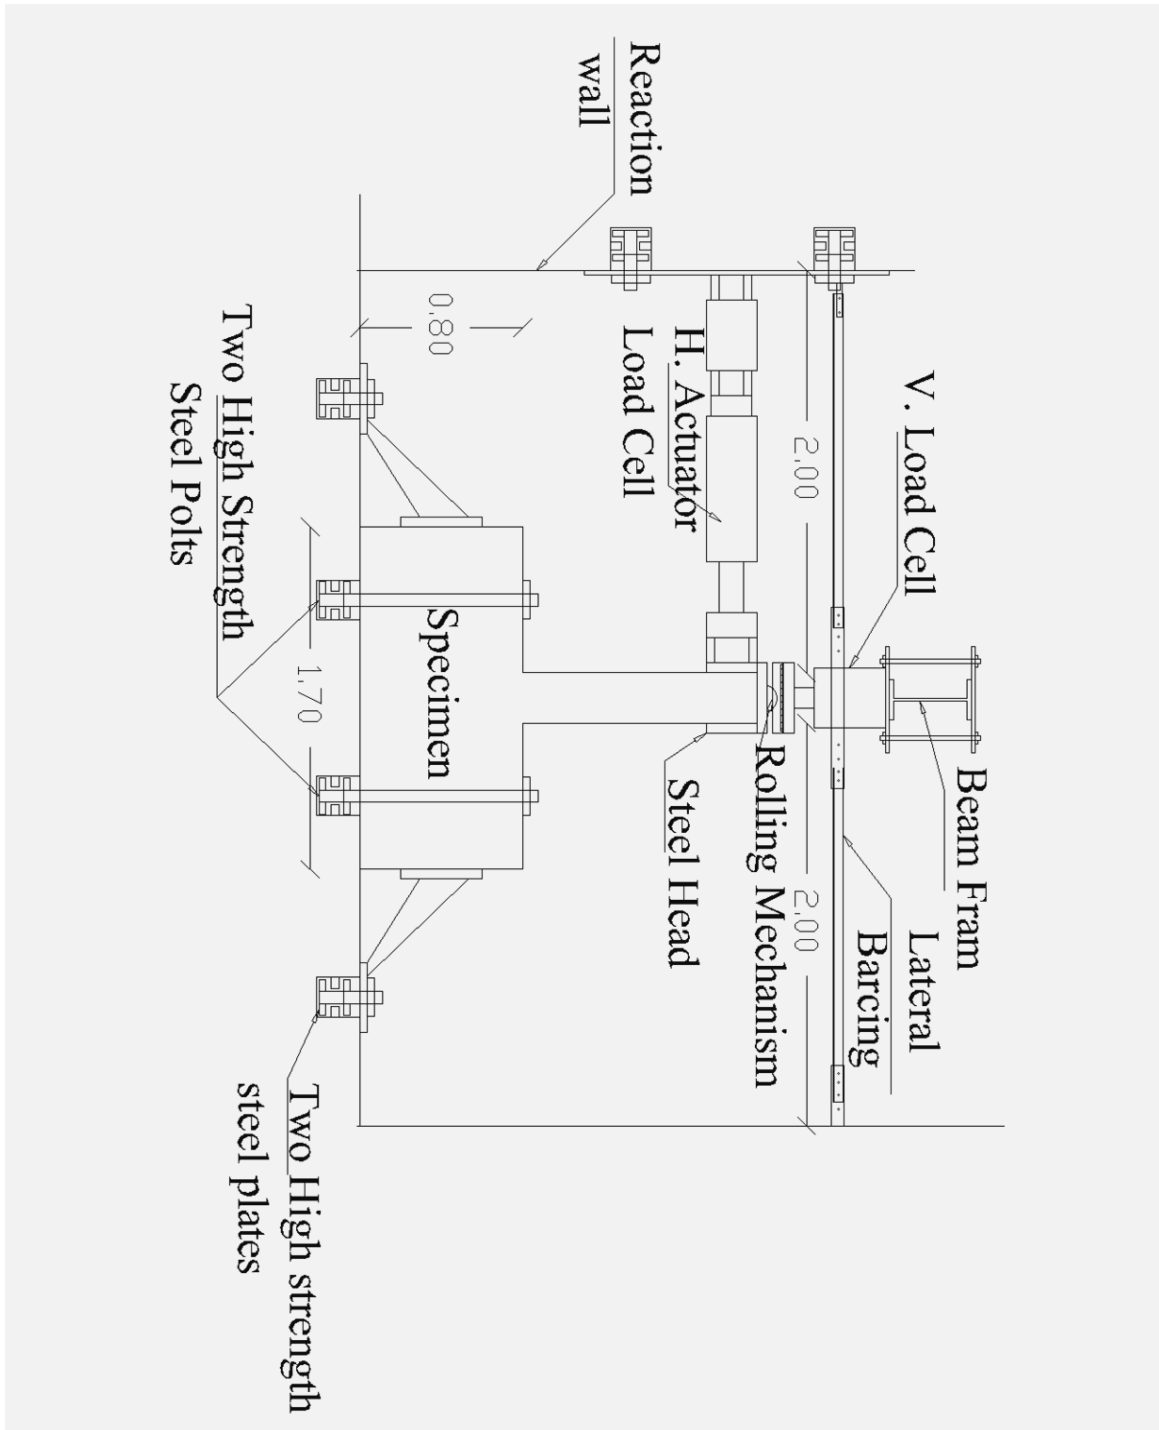
FIGURE 4.14: TEST SETUP

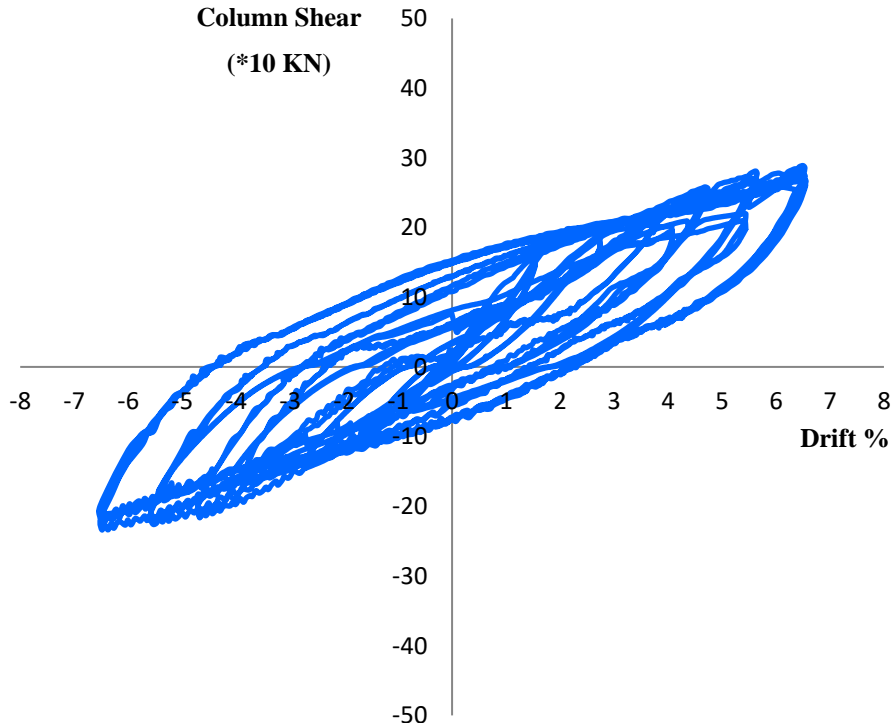
**Figure 5.1** shows the shear force-drift ratio hysteresis response of specimen CSF10-NP. The flexural nature of the response is clear through the cycles' shape which also shows a strain hardening trend, reaching a significant drift of about 6.5% without any strength degradation. (Farag and Hassan, 2015)

**Figure 5.1:** Shear force-drift hysteresis response of specimen CSF10-NP

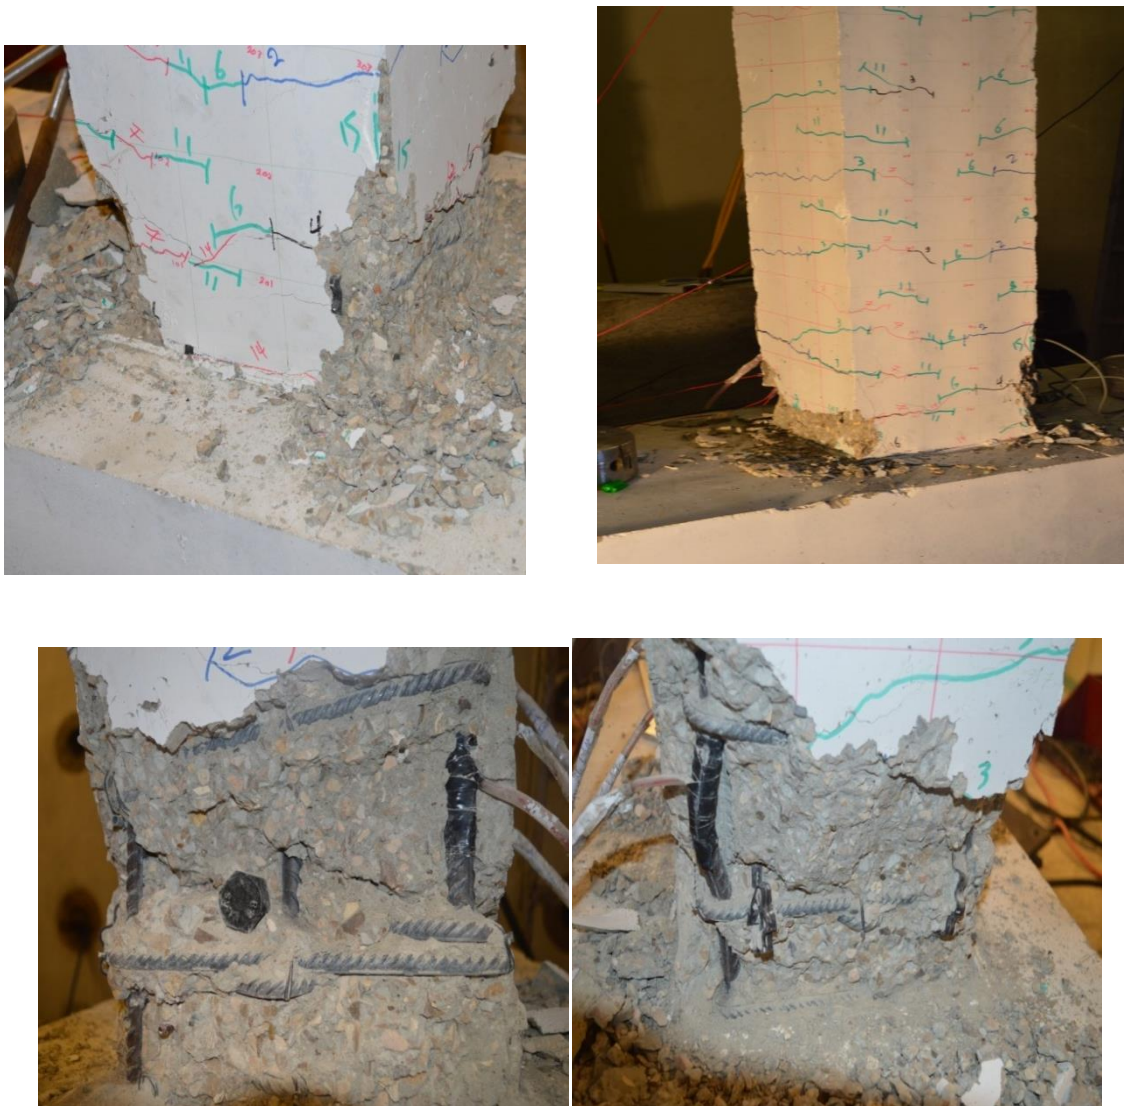
Figure 5.2 shows the failure mode of specimen CSF10-NP under the effect of the applied displacement protocol. The specimen was failing in a flexural tension failure mode as predicted in the theoretical analysis. (Frag and Hassan, 2015)

Figure 5.2: Failure mode of specimen CSF10-NP

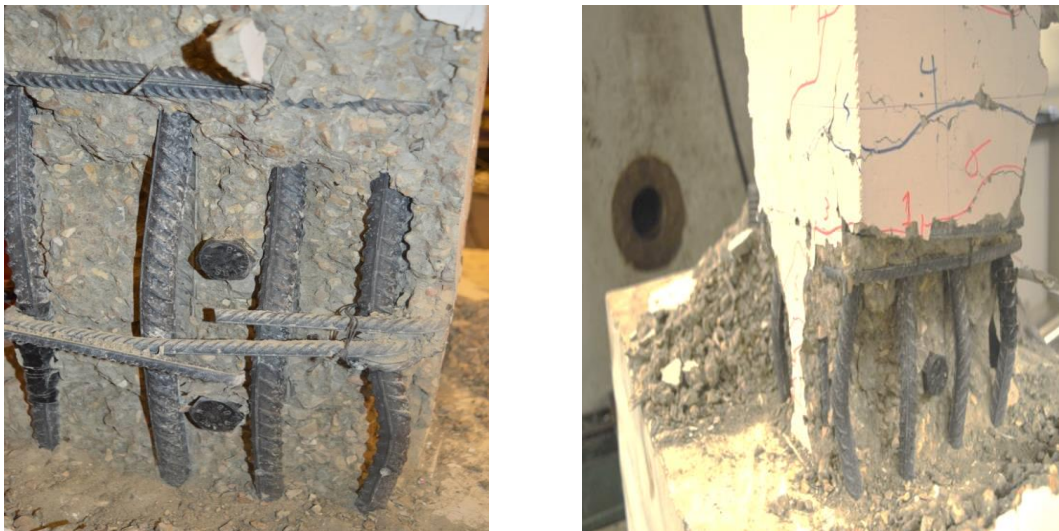
**Figure 5.3: Failure mode of specimen CSS15-NP**

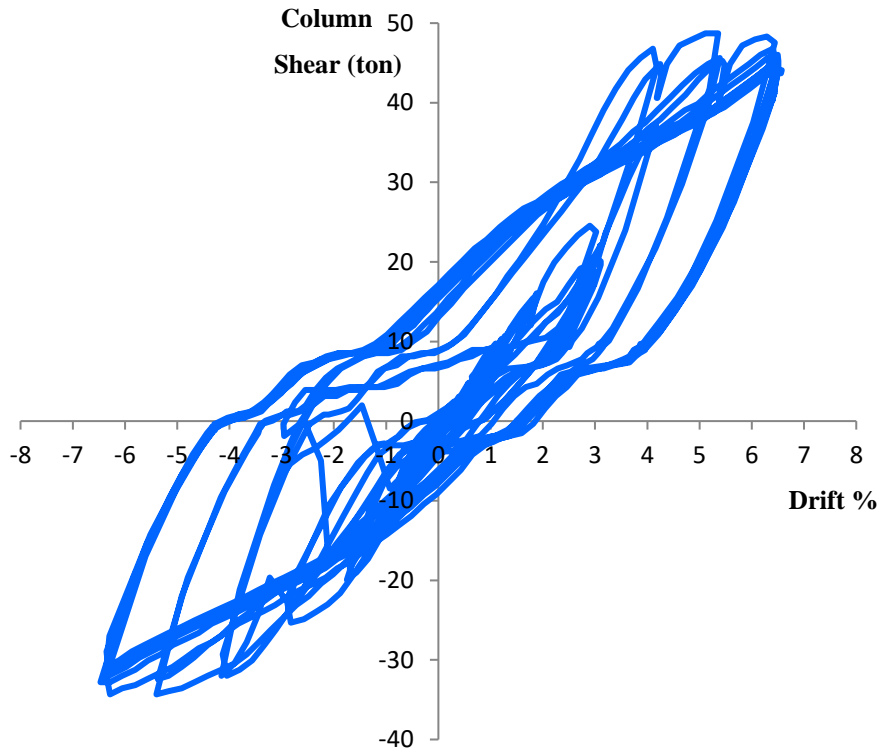
**Figure 5.4** shows the shear-drift hysteresis response of specimen CSS15-NP until the test termination drift ratio of about 6.5% due to actuator stroke capacity. A strain hardening trend reached the significant drift of 6.5% without any strength degradation evident. This drift ratio is believed to exceed any practical drift ratio corresponding to collapse prevention limit state. The peak shear value was 490 KN which excessively exceeded the predicted value of 190 KN that was originally expected to correspond to the flexural capacity of the section. (Frag and Hassan, 2015)

**Figure 5.4: Shear force-drift hysteresis response of specimen CSS15-NP**

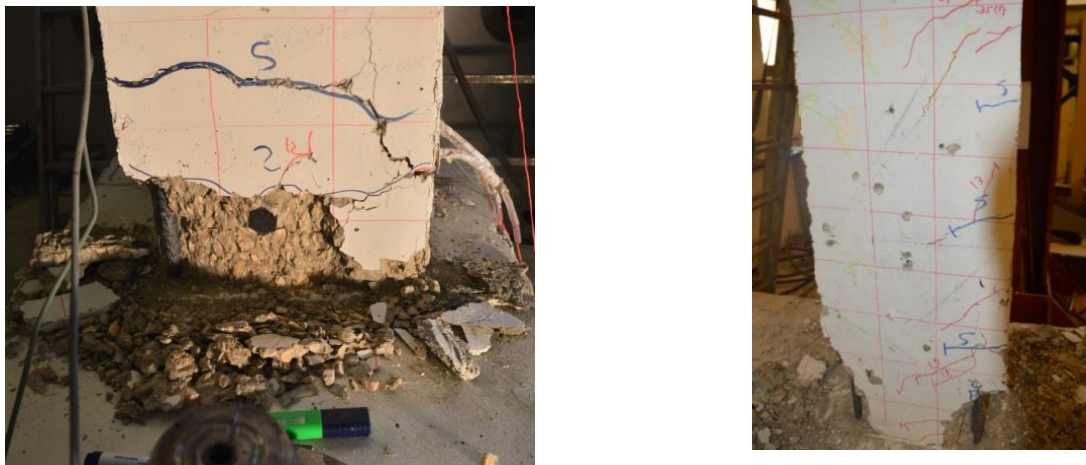
**Figure 5.5: Failure mode of specimen CSS10-EP**

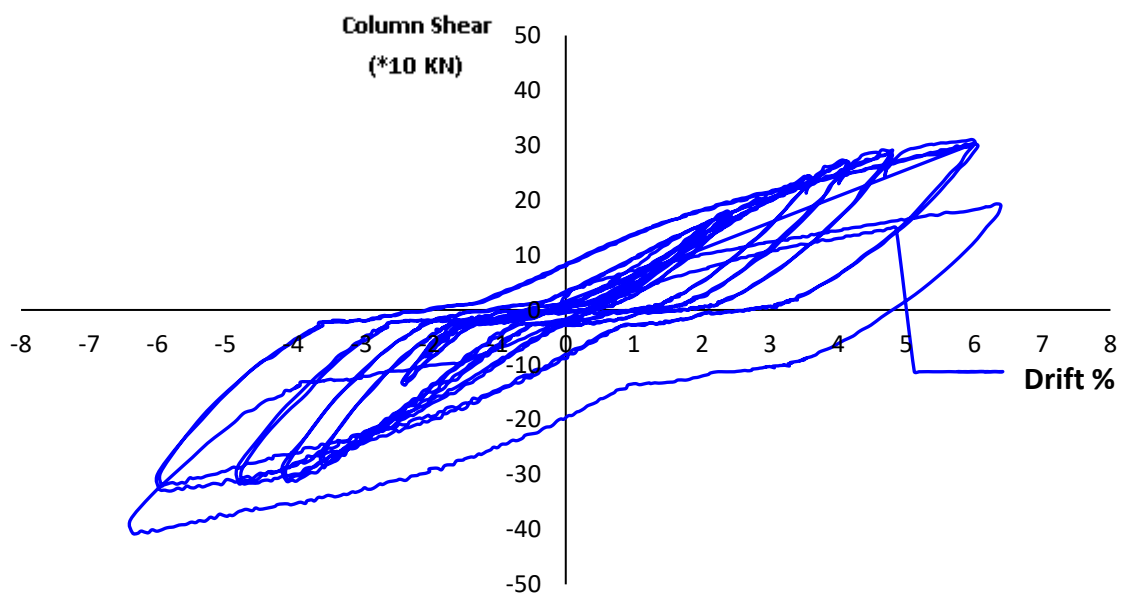
**Figure 5.6** shows the shear-drift hysteresis response of specimen CSS10-EP. The specimen initially yielded in flexure; however, large deformation resulting from strain hardening at 90 degree has left hooks of the hoops opened and left the concrete in compression poorly confined. This has resulted in crushing the concrete in compression.(Farag and Hassan, 2015)

**Figure 5.6: Shear force-drift hysteresis response of specimen CSS10-EP**

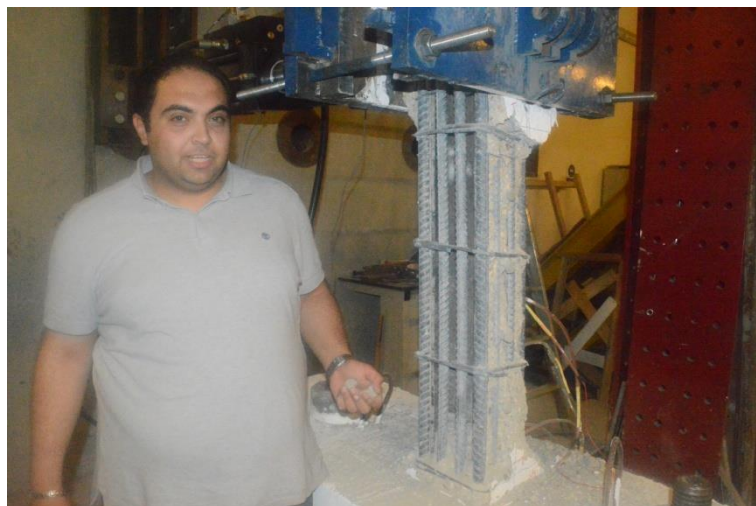
**Figure 5.9: Damage pattern of specimen CSS15-E-25**

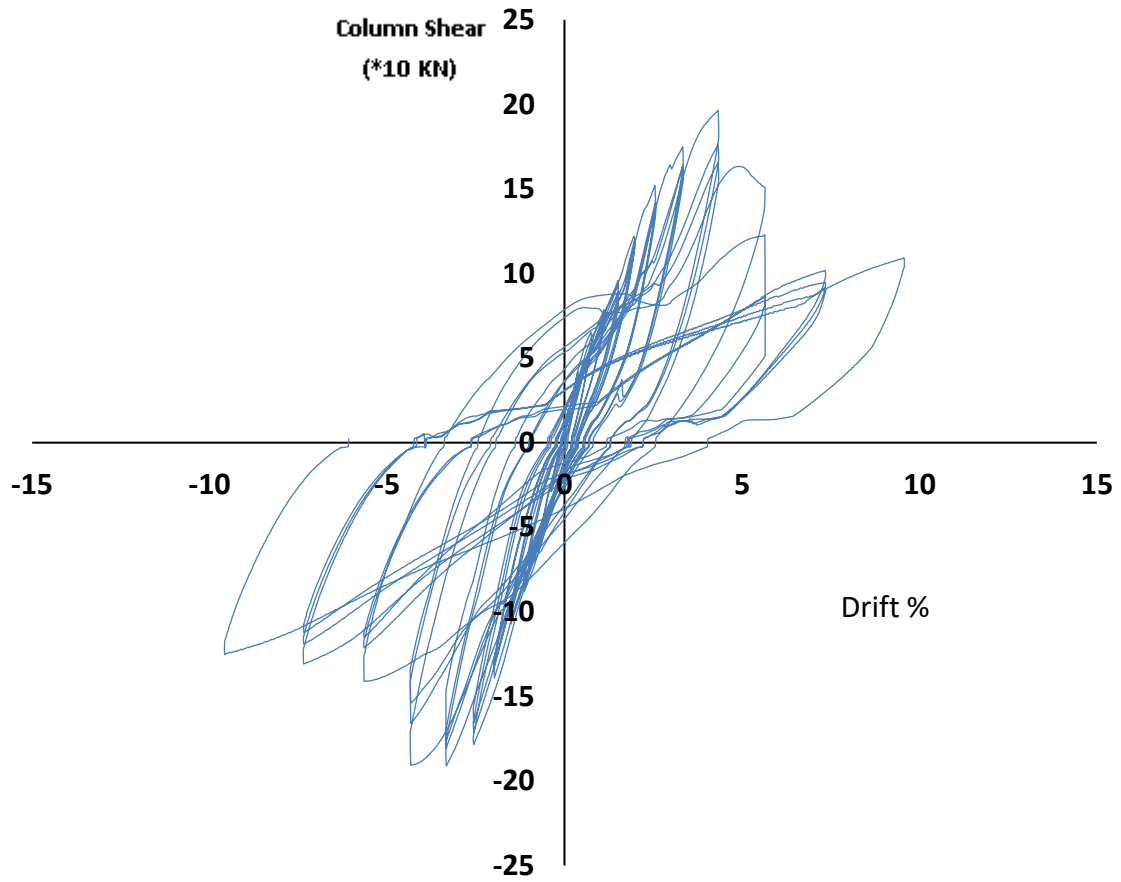
Figure 5.10: Shear force-drift hysteresis response of specimen CSS15-E-25

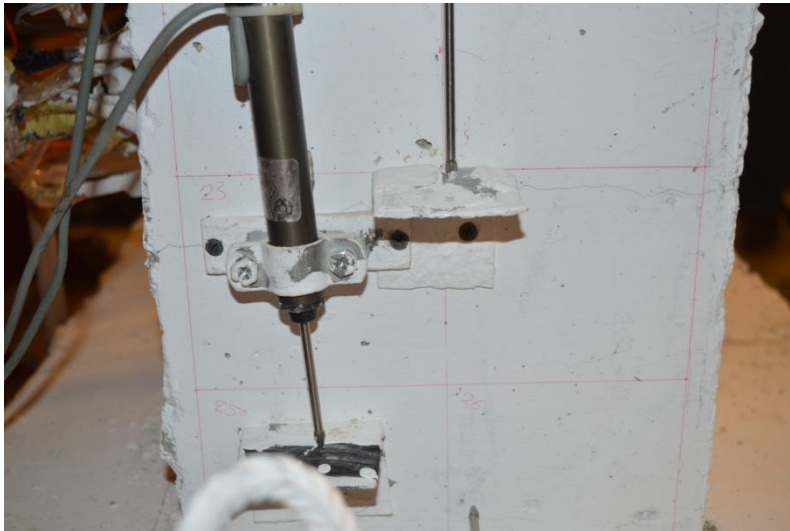
**Figure 5.11: Specimen CSF-10-16-N at initial displacement (Hair cracking)**

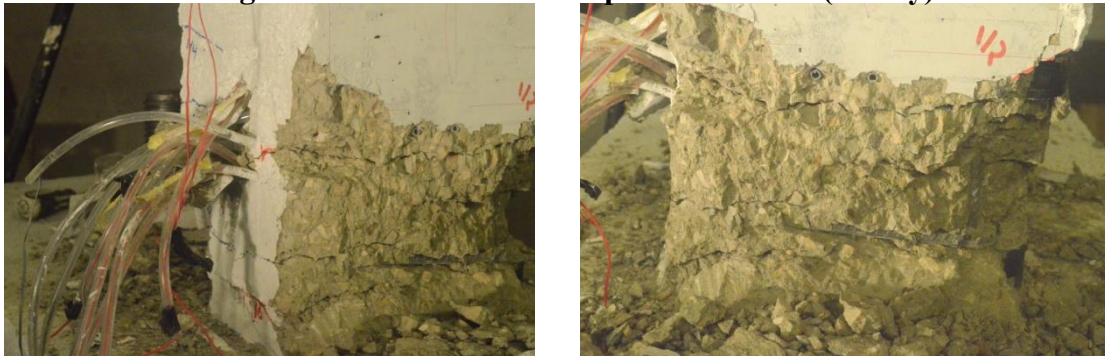
Figure 5.46: CSF-10-75 Deep flexure cracks

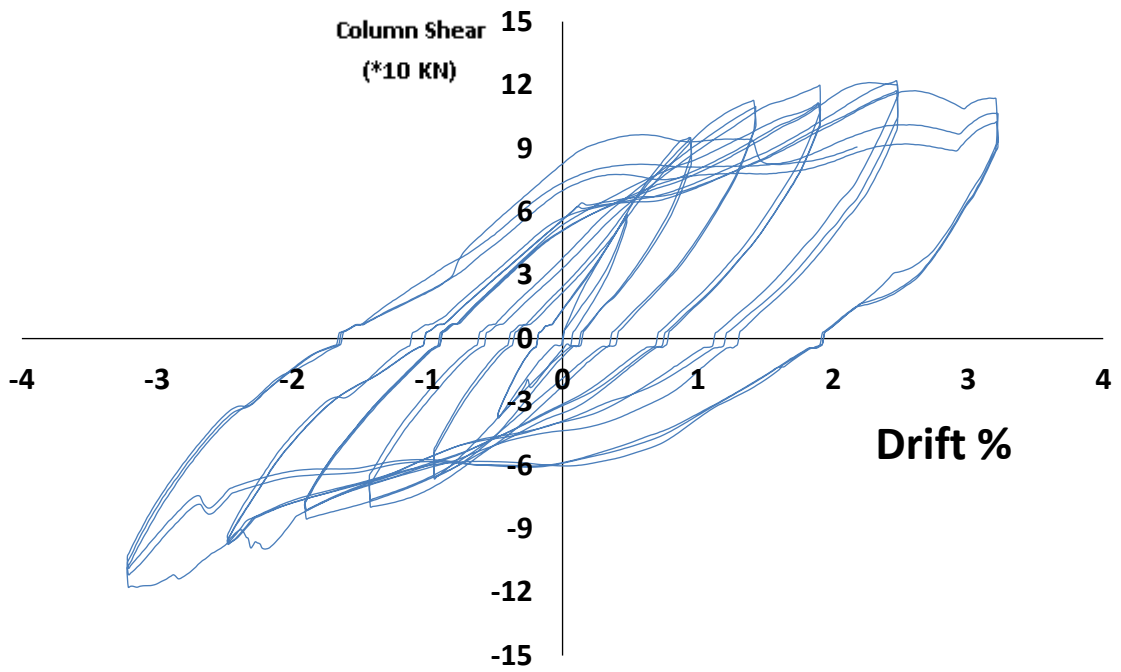
Figure 5.48: Shear force-drift hysteresis response of specimen CSF 10-7.5-N

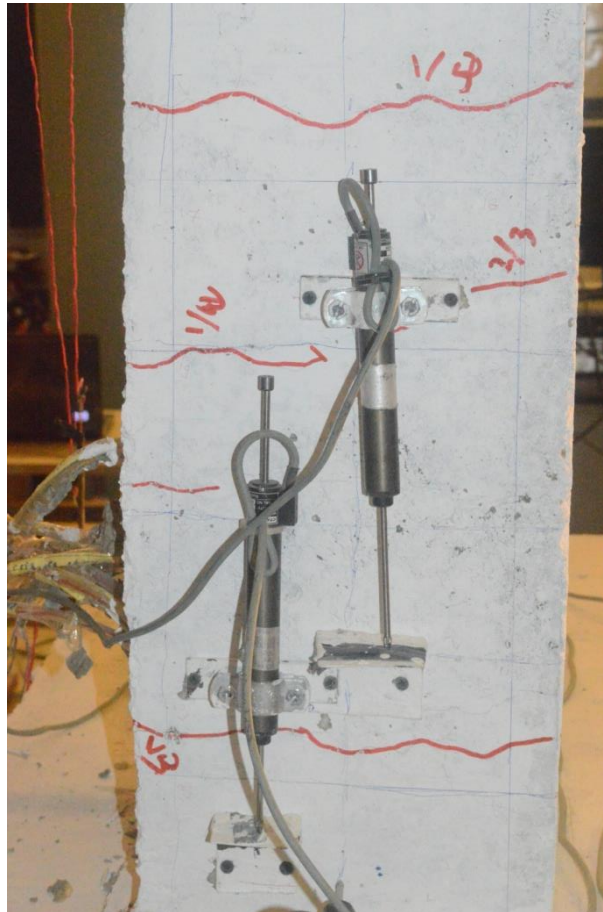
**Figure 5.63: Specimen CSF-0-7.5-N at initial cracking ( $0.75 \Delta y$ )**

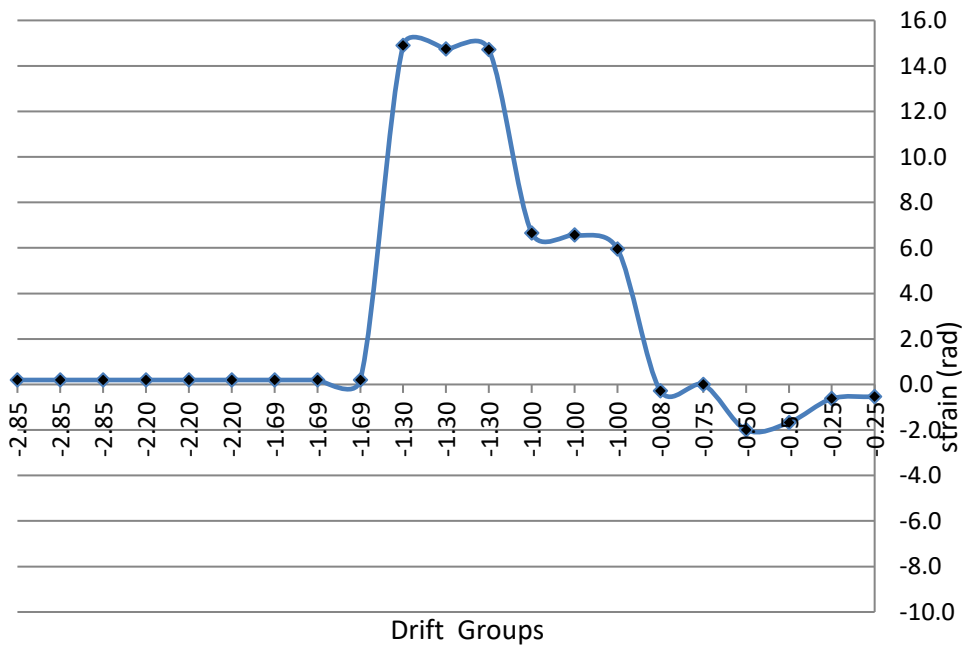
Figure 5.85: CSF-0-7.5-N Tension steel bar strain Vs Drift groups (125mm) (Tension side)

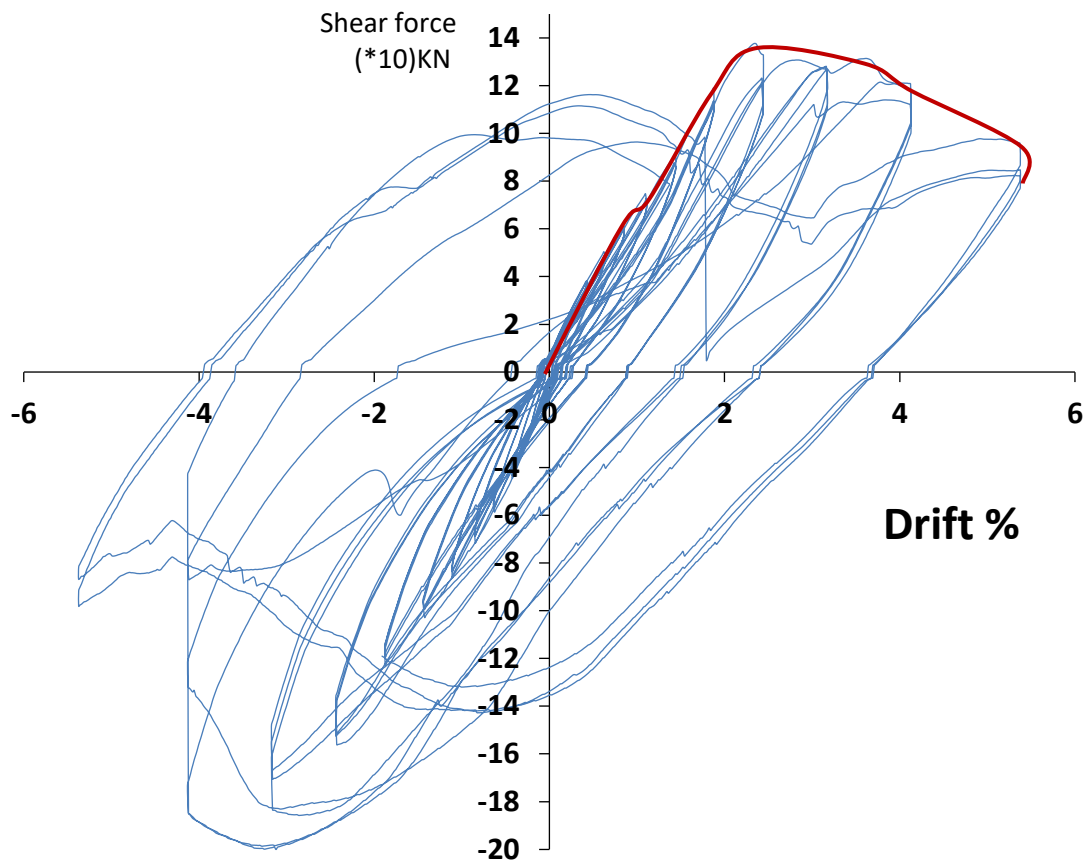
Figure 5.86: Specimen CSF 10-160mm - N backbone curve

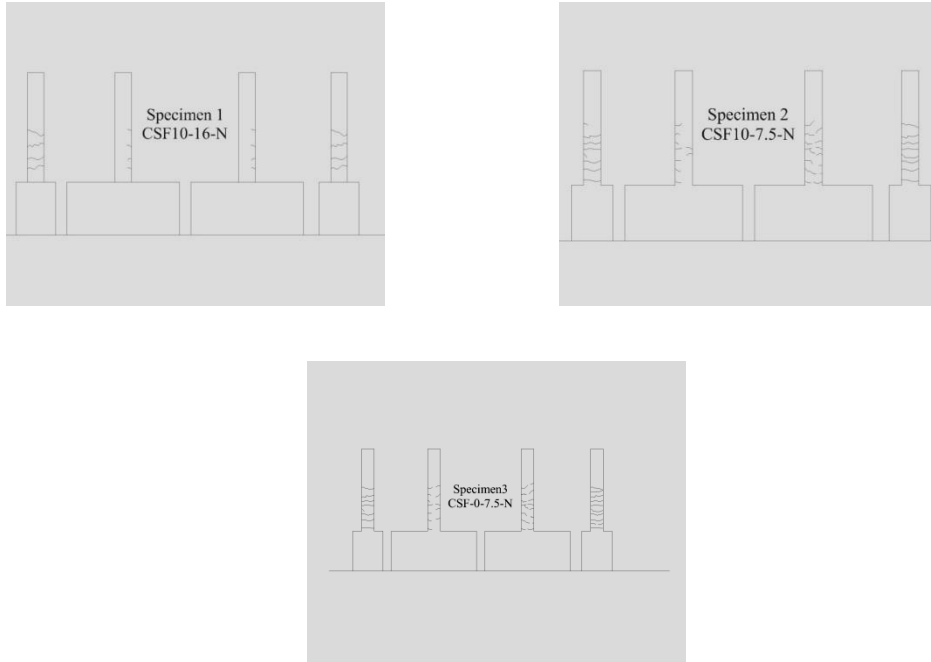
Figure 5.92: Crack pattern at ( $\Delta y$ ) lateral displacement

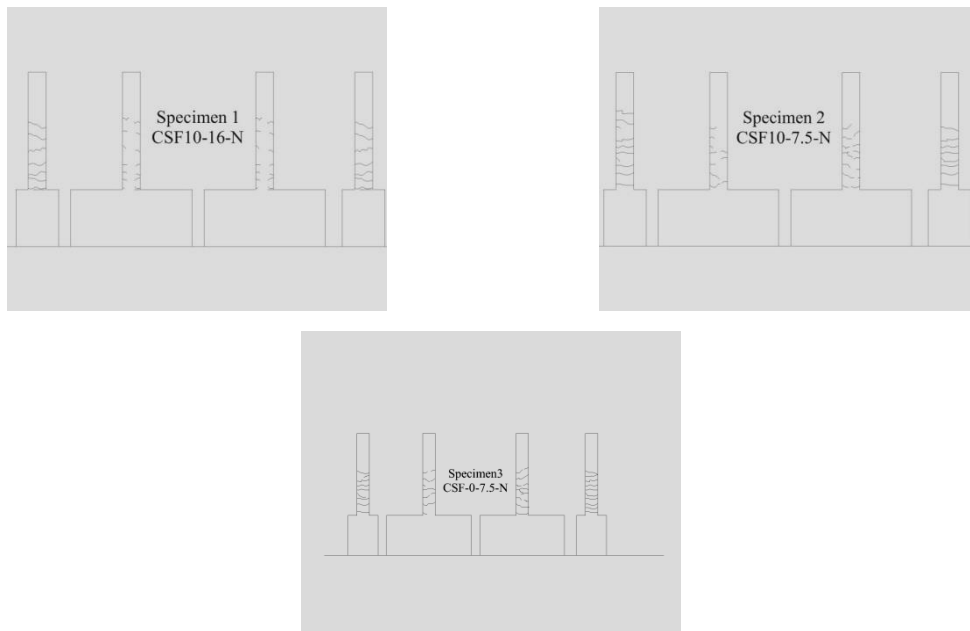
Figure 5.93: Crack pattern at ( $1.3 \Delta y$ ) lateral displacement

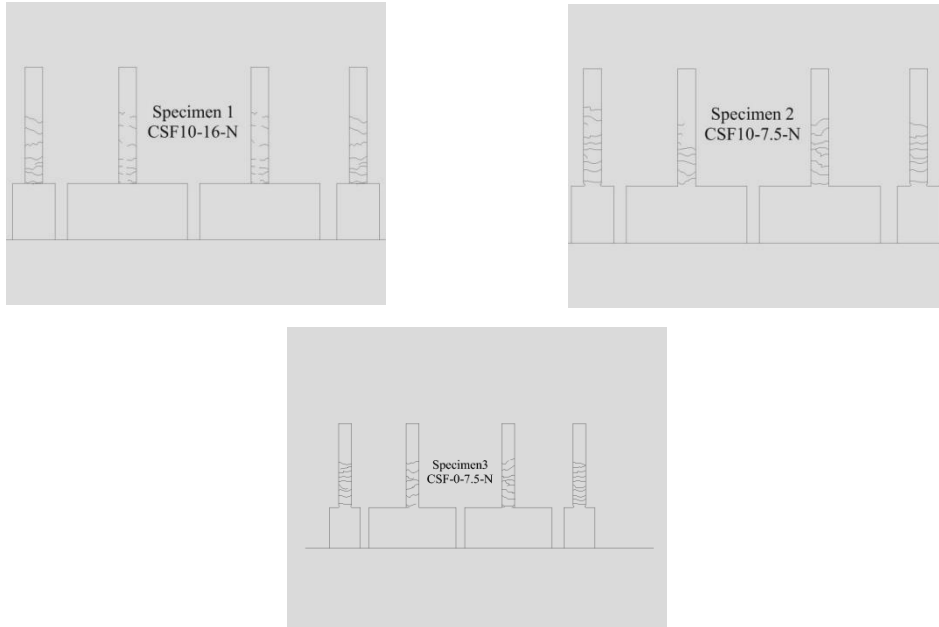
Figure 5.94: Crack pattern at  $(2.2 \Delta y)$  lateral displacement

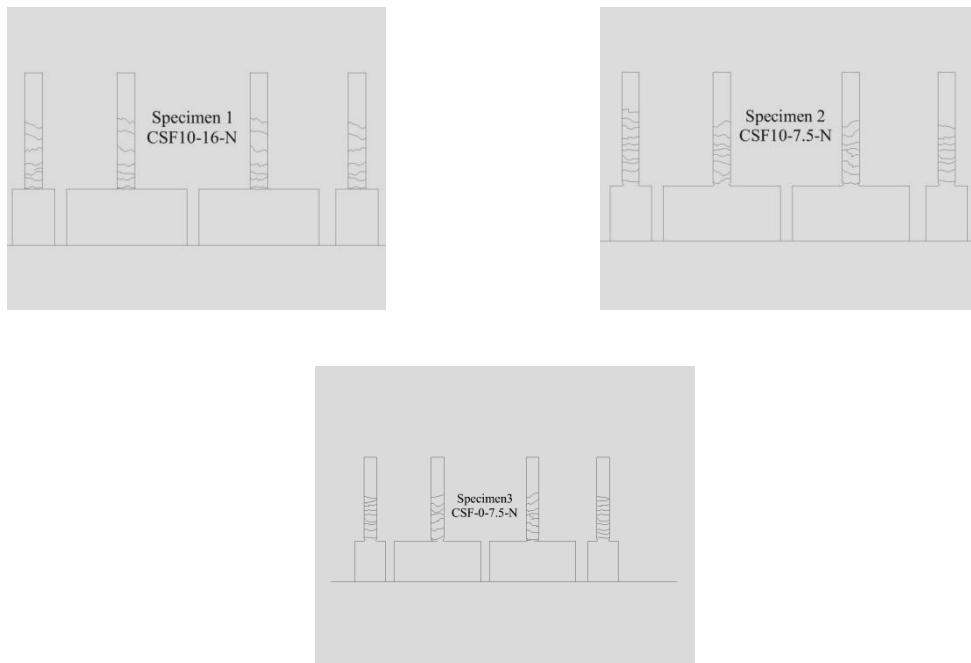
Figure 5.95: Crack pattern at  $(3.73 \Delta y)$  lateral displacement

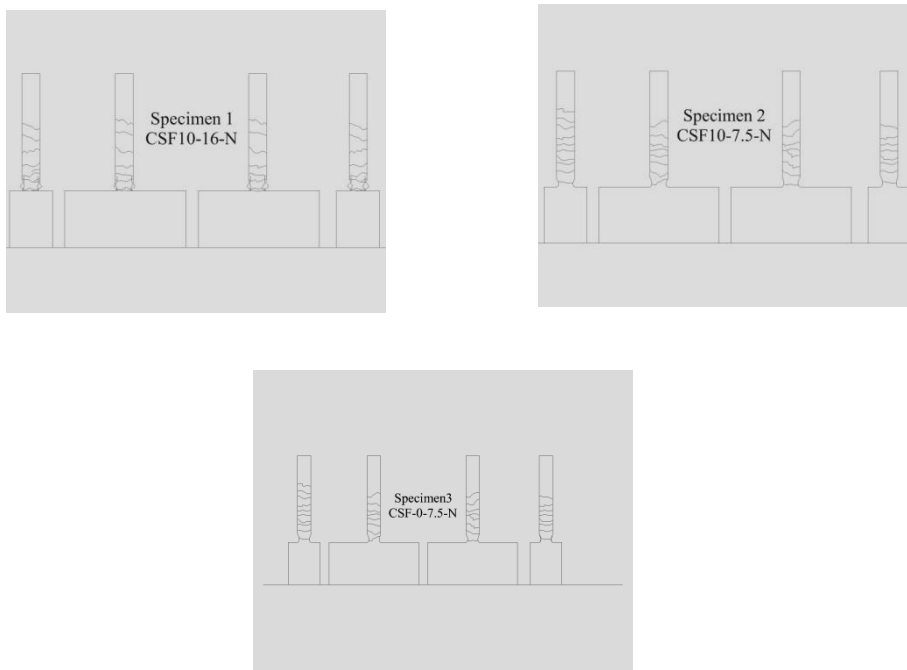
Figure 5.97: Crack pattern at (End of the test) lateral displacement

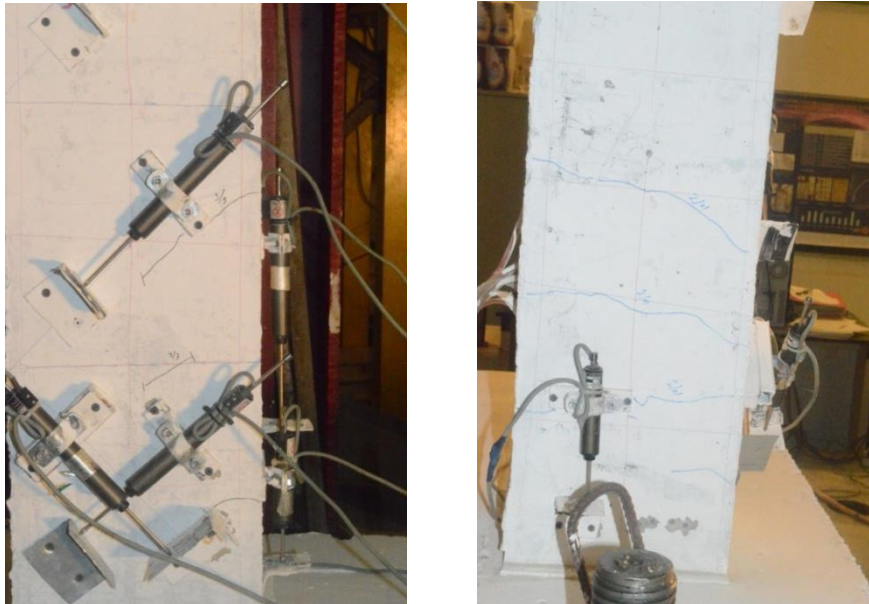
**Figure 5.98: Specimen CSS-15-E at initial displacement (hair cracking)**

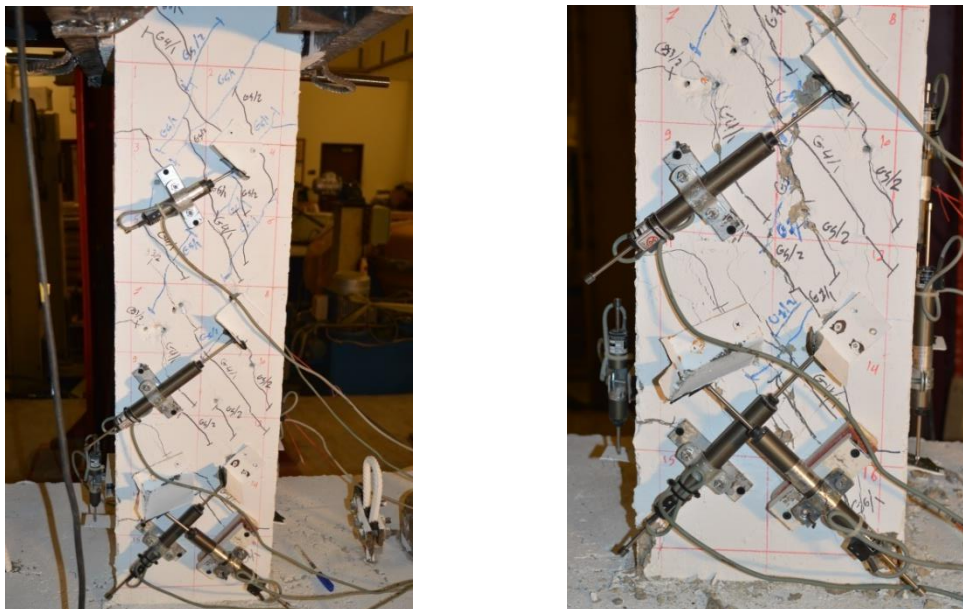
Figure 5.116: CSS-20-E Opening cracks near to base  $2.85\Delta y$

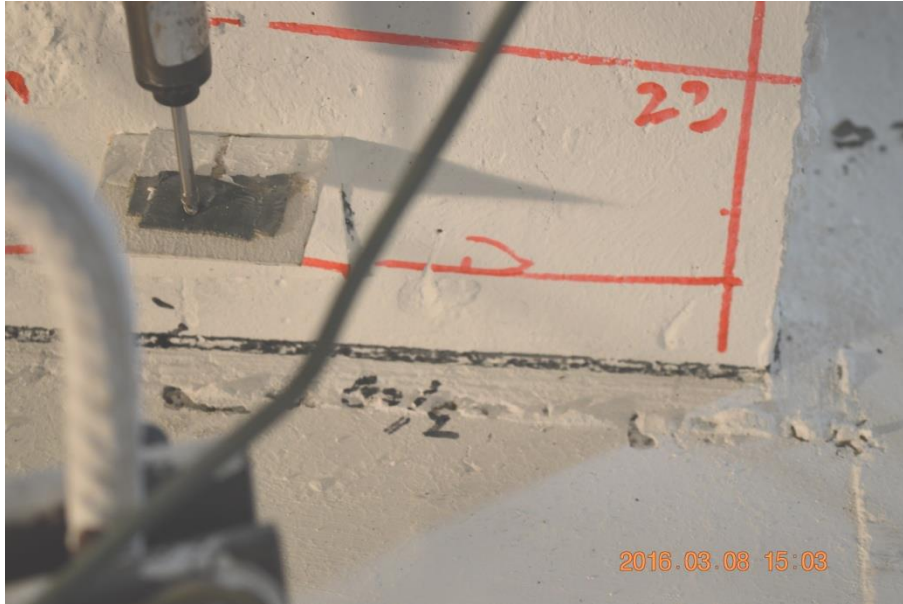
Figure 5.132: CSS 40-E start slipping at  $\Delta y$

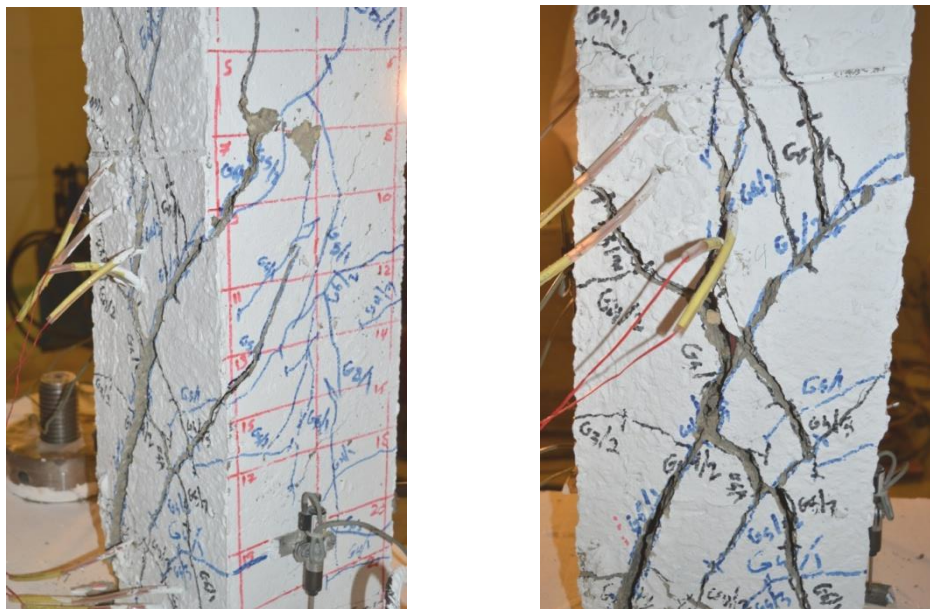
Figure 5.135: CSS 40-E Opening cracks 2.856  $\Delta y$

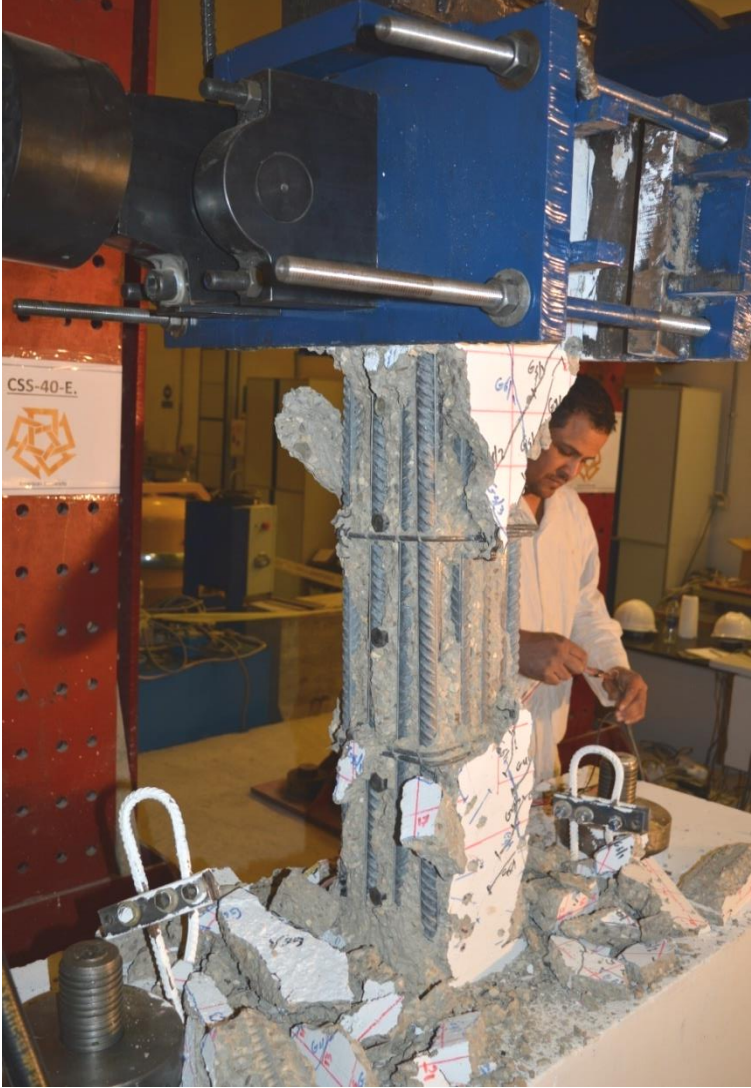
**Figure 5.138: CSS 40-E failure at the end of the test**

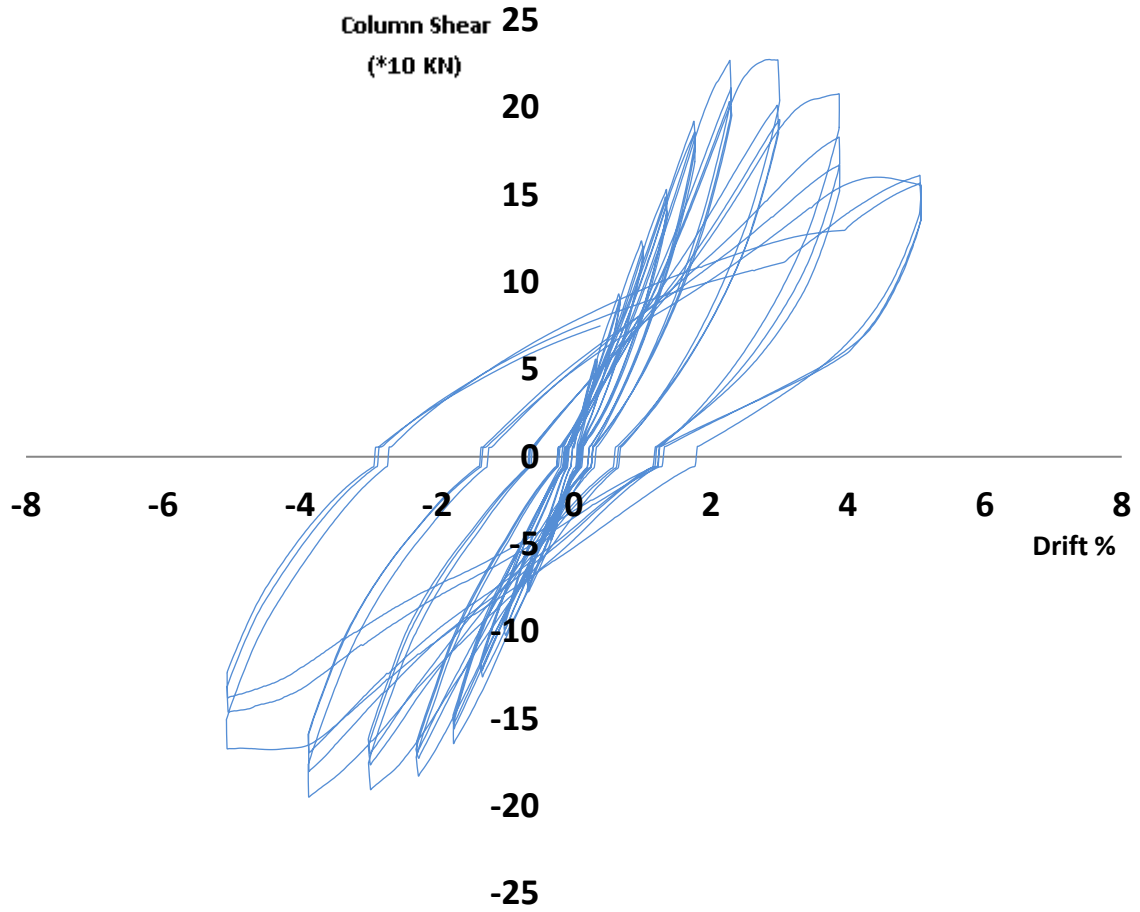
Figure 5.139: Shear force-drift hysteresis response of specimen CSS 40-E

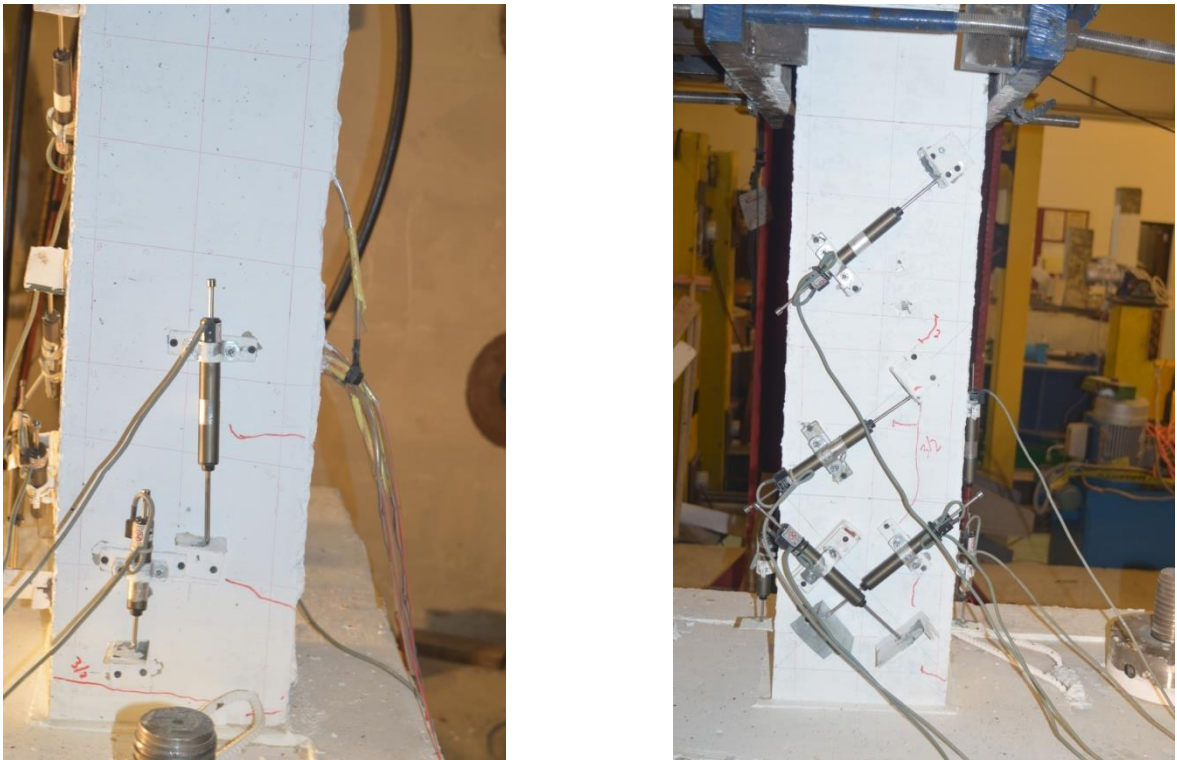
**Figure 5.148: Specimen CSS-60-E at initial cracking ( $0.5 \Delta y$ )**

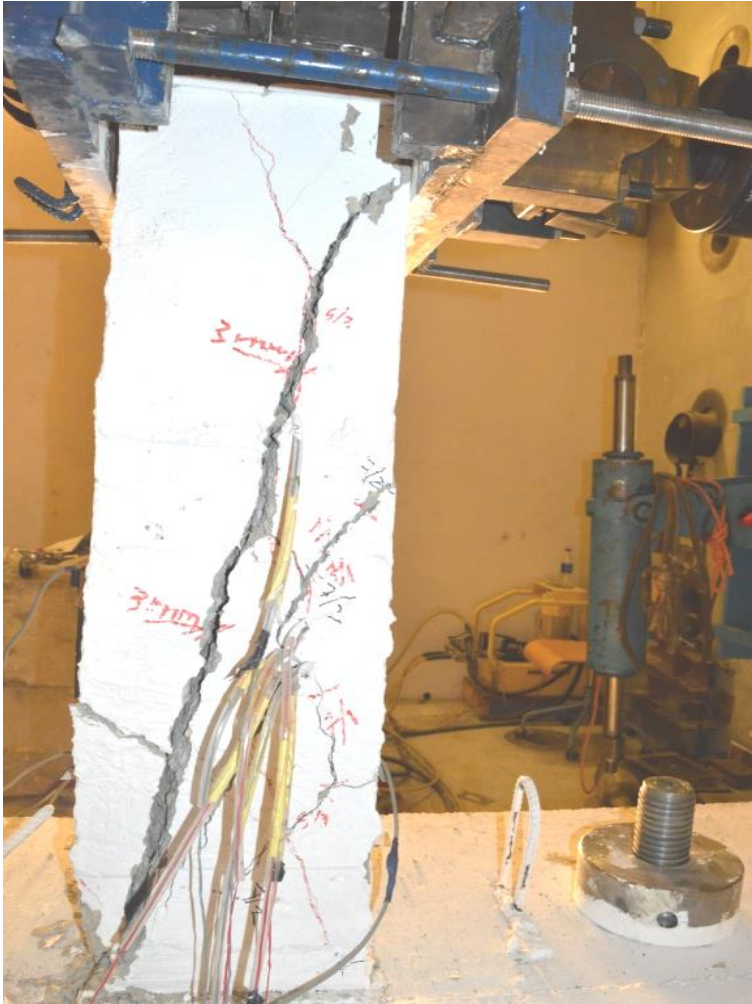
**Figure 5.153: CSS-60-E failure at the end of the test**
