### Seismic performance of steel-reinforced concrete composite columns of older and modern construction

**Seismic Performance of Steel-Reinforced concrete Composite  
Columns of Older and Modern Construction**

**Masters of Science in Construction Engineering**

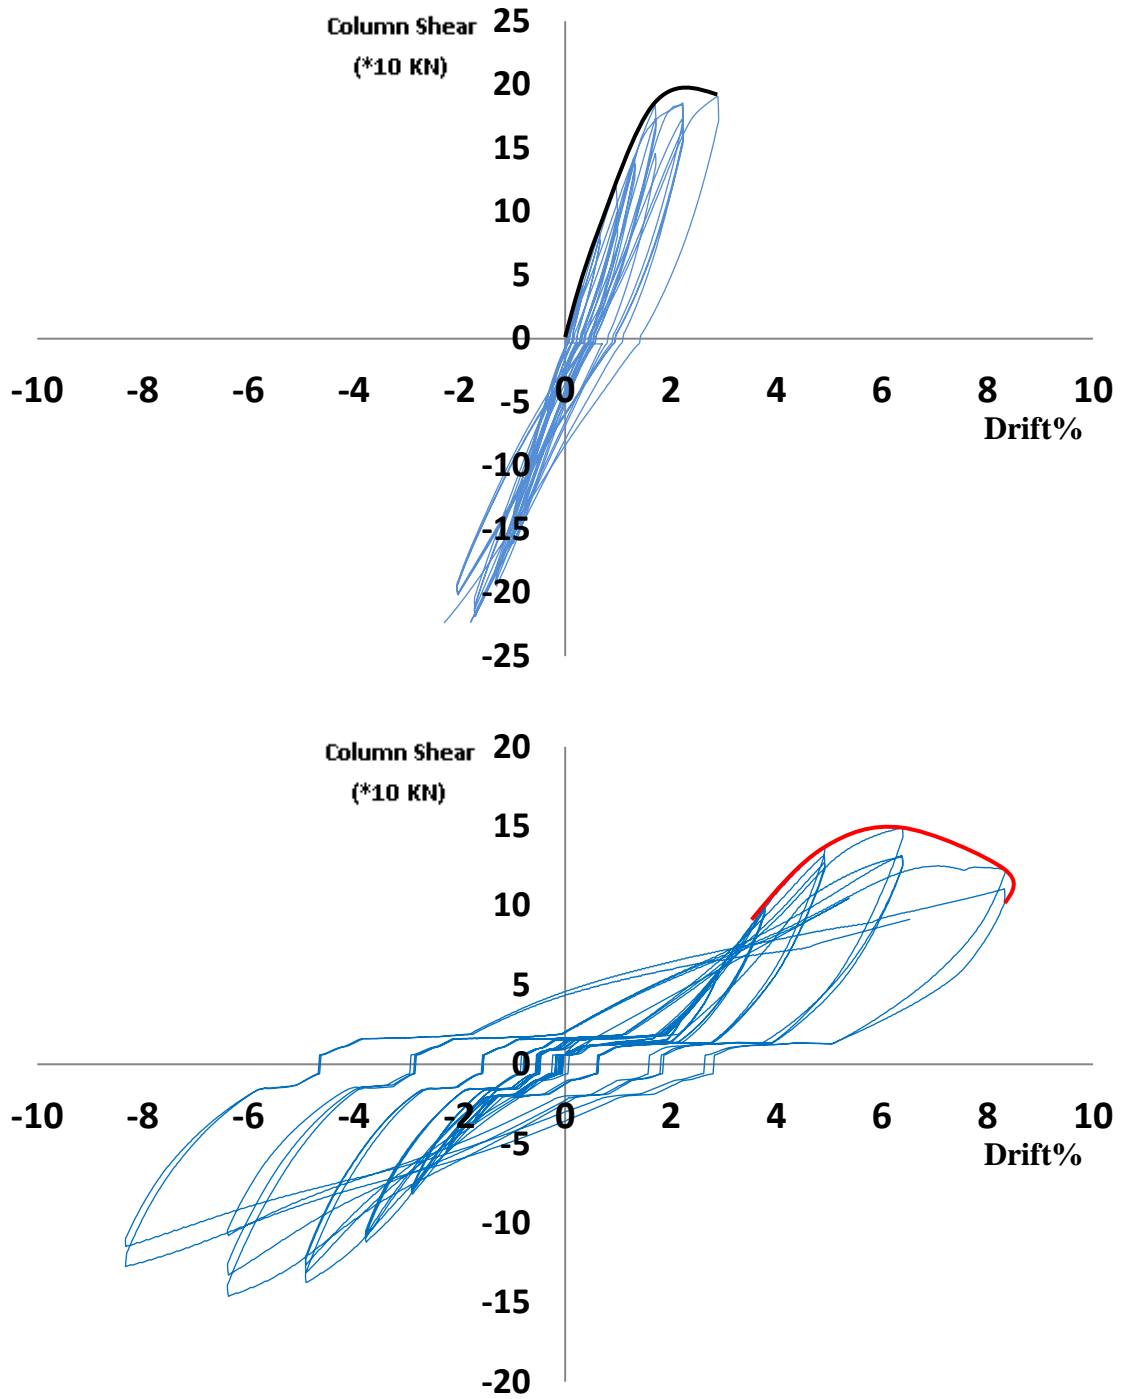
Figure 5.154: Shear force-drift hysteresis response of specimen CSS 60-E

Figure 5.144 shows two shear force drift hysteresis response of specimen CSS60-E. During the test, it was noted a high inclination of axial load cell affected unaccepted eccentricity. It was decided to complete the test with the same loading protocol but without axial load to get the curve slope degradation. The red hysteresis show drift with the response under axial load of 60%, but the blue hysteresis show the drift without axial load, only horizontal load.

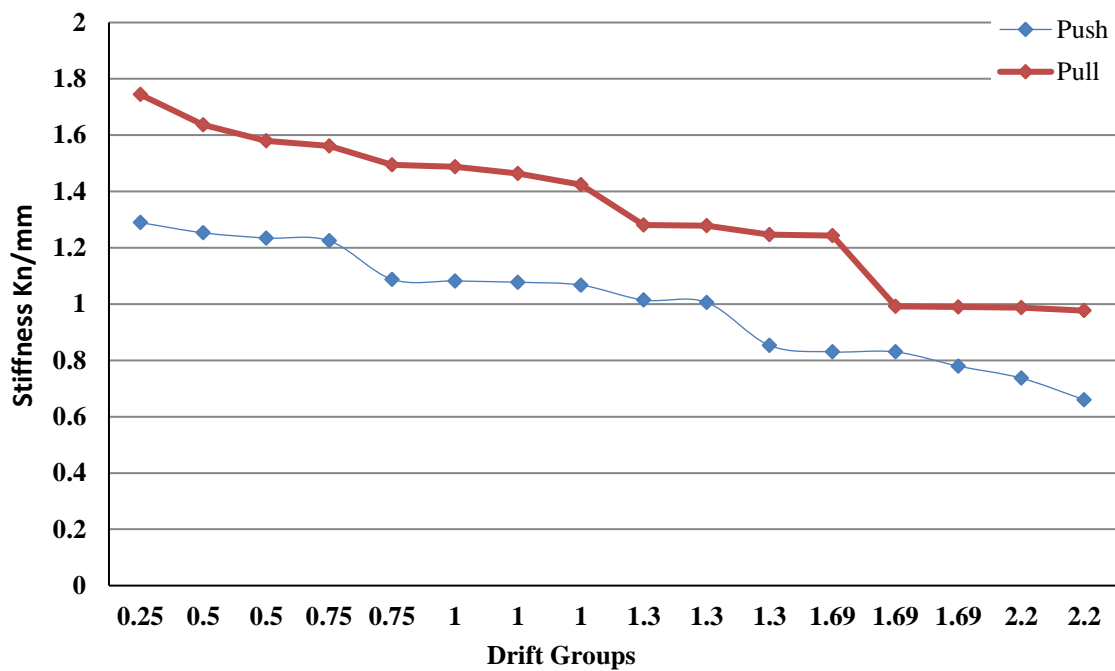
Figure 5.155: Peak to Peak stiffness of specimen CSS-60-E

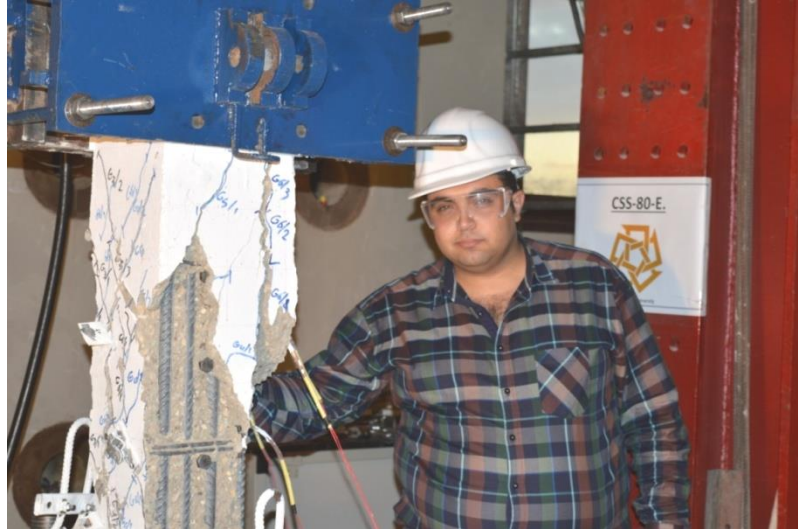
Figure 5.170: CSS-80-E failure end of the test

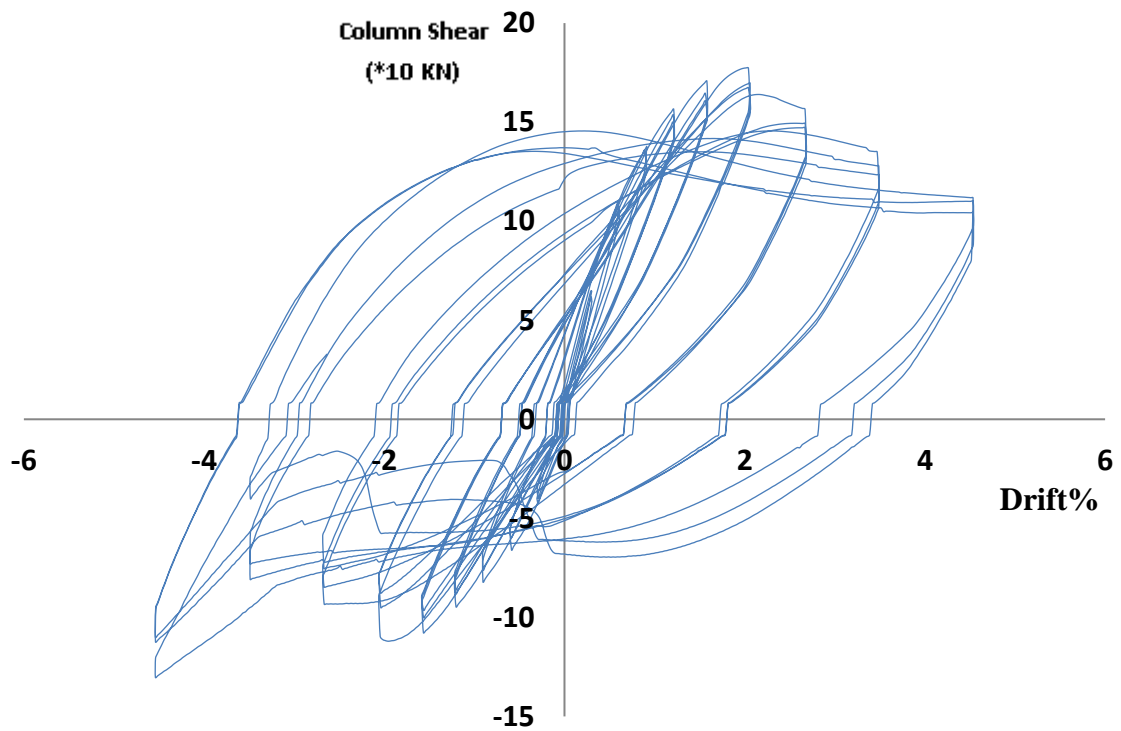
Figure 5.171: Shear force-drift hysteresis response of specimen CSS-80-E

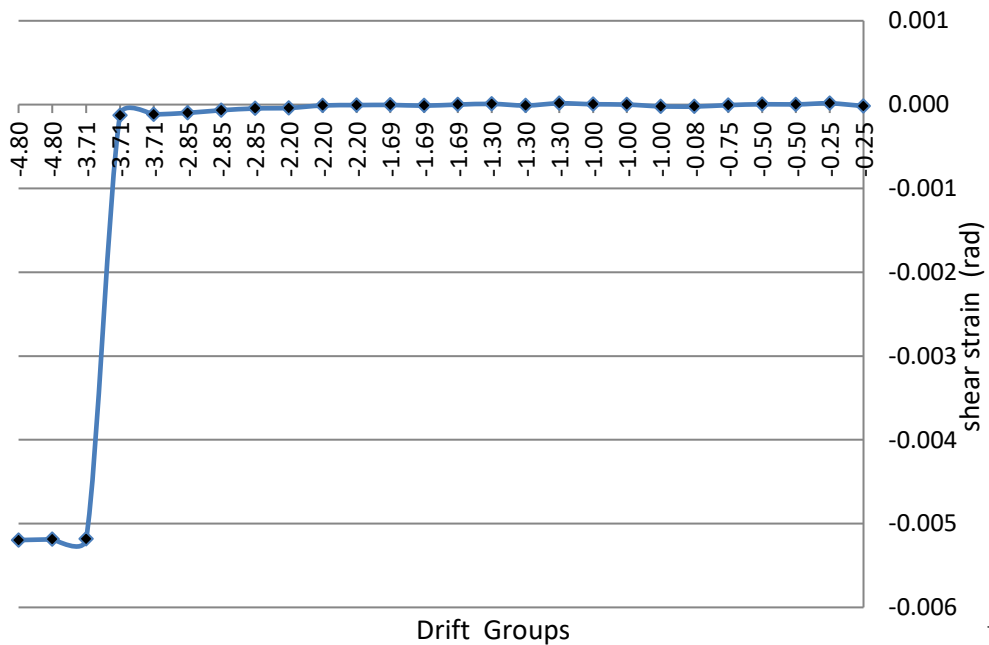
Figure 5.179: CSS-80-E Compression shear strain (rad) Vs Drift groups (Diagonal LVDTs 4-27)

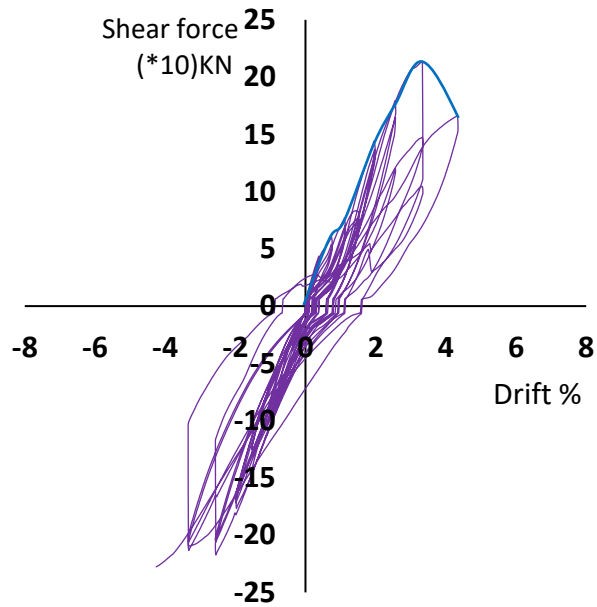
Figure 5.180: Specimen CSS 15 – E backbone curve

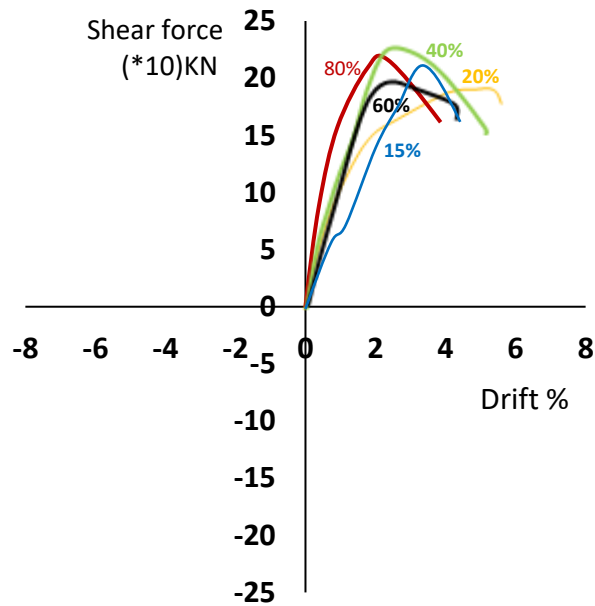
Figure 5.185: Shear deficient old building specimens Backbone curves

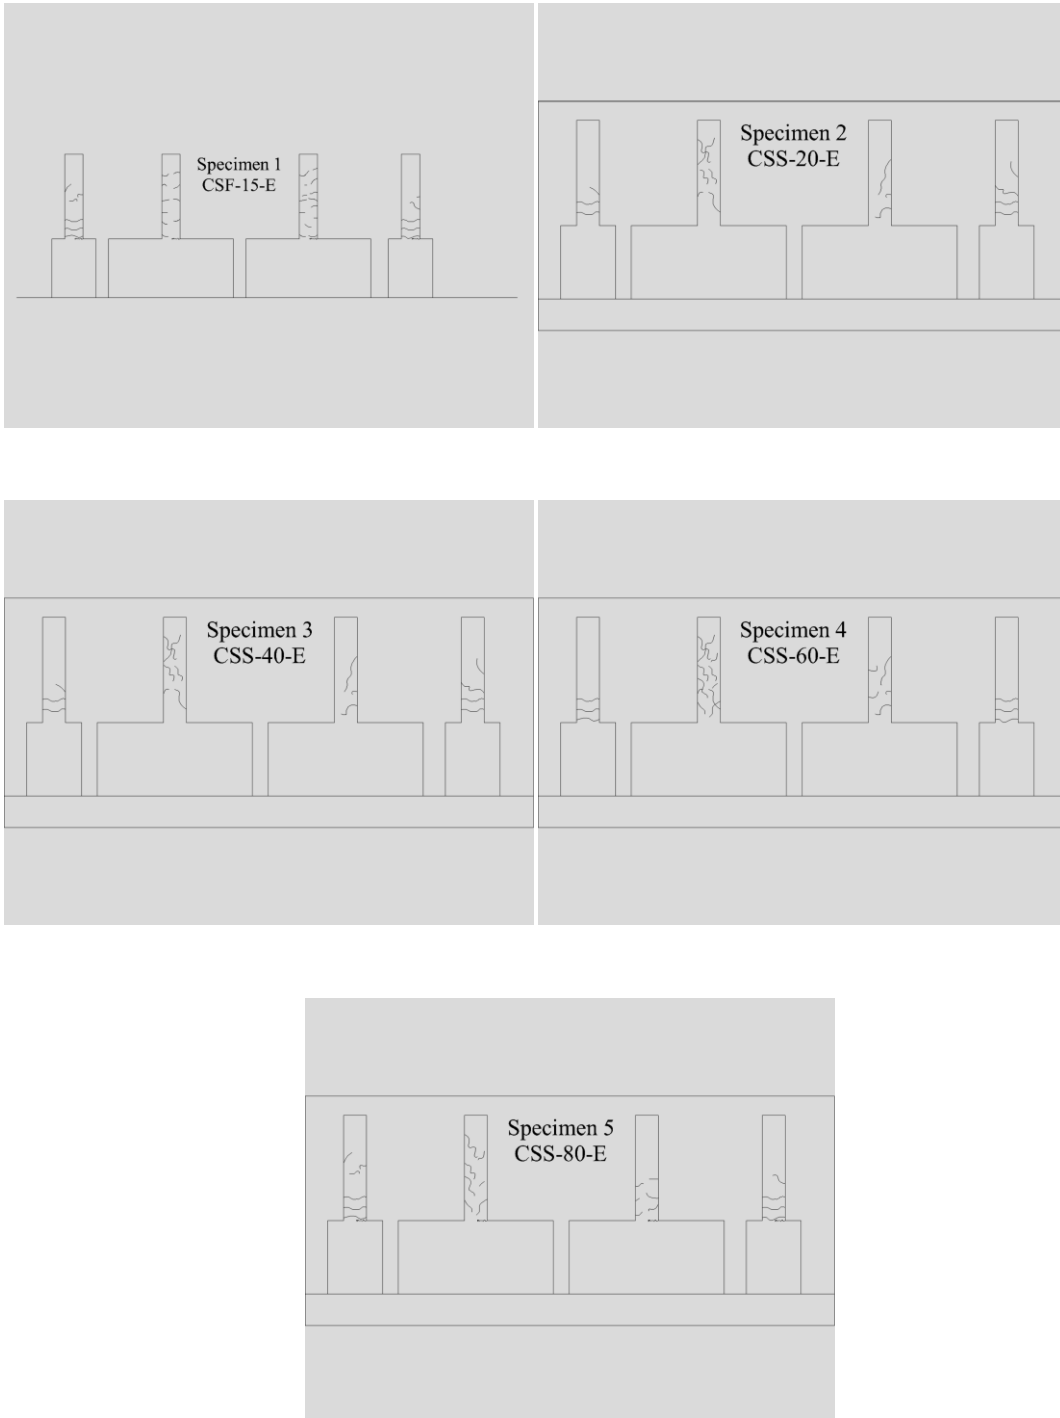
Figure 5.191: Crack pattern at ( $\Delta y$ ) lateral displacement

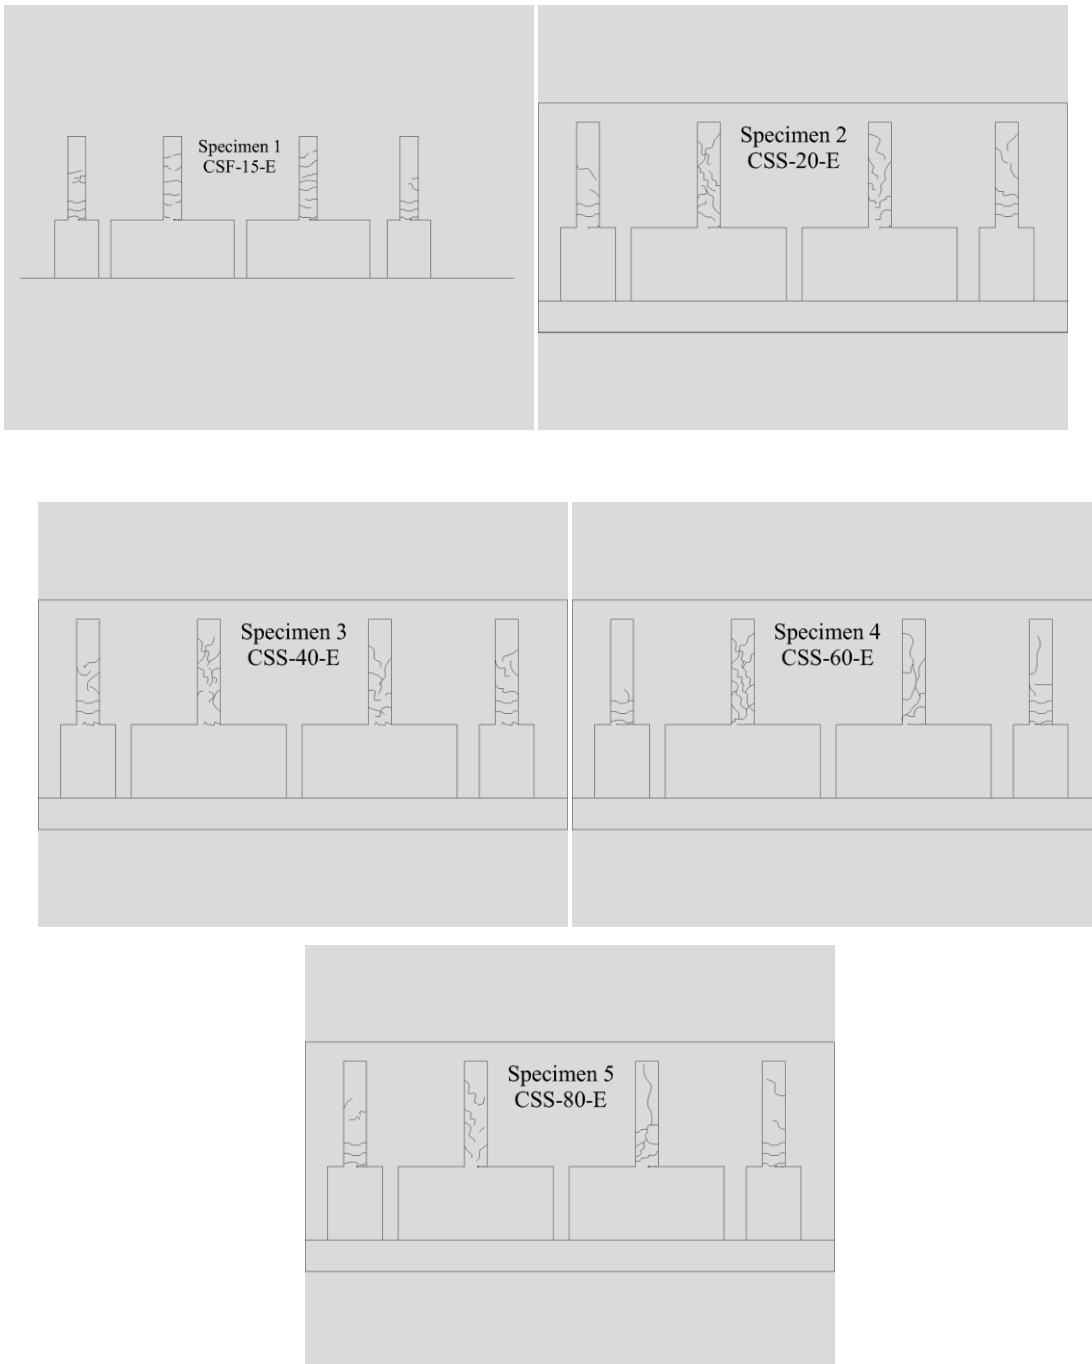
Figure 5.192: Crack pattern at  $(1.3 \Delta y)$  lateral displacement

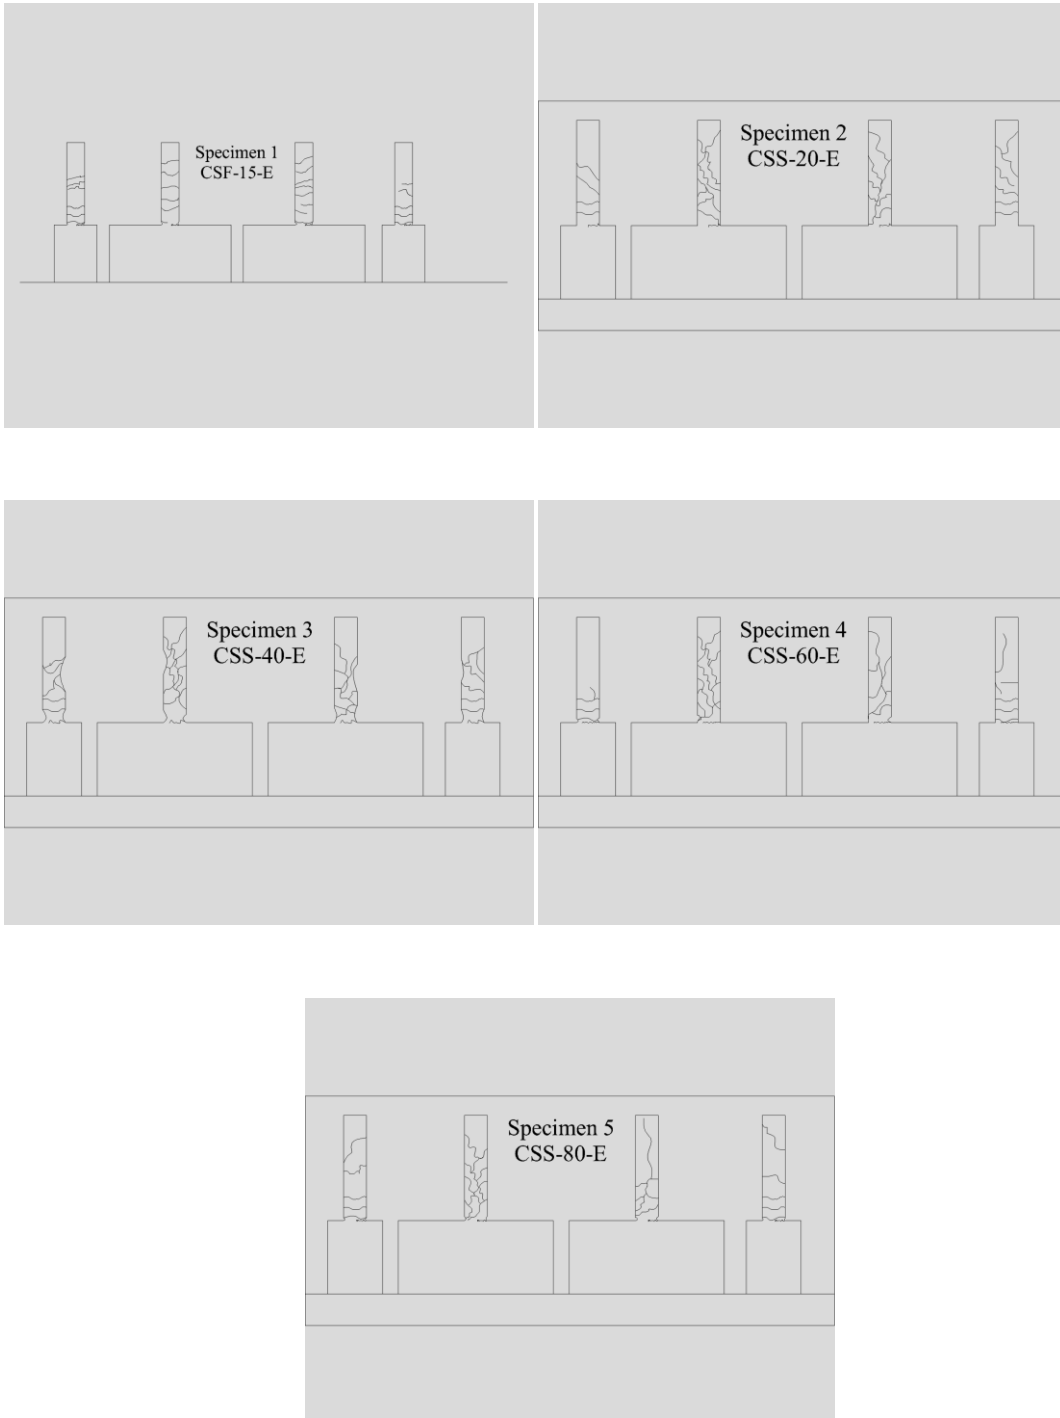
Figure 5.193: Crack pattern at  $(2.2 \Delta y)$  lateral displacement

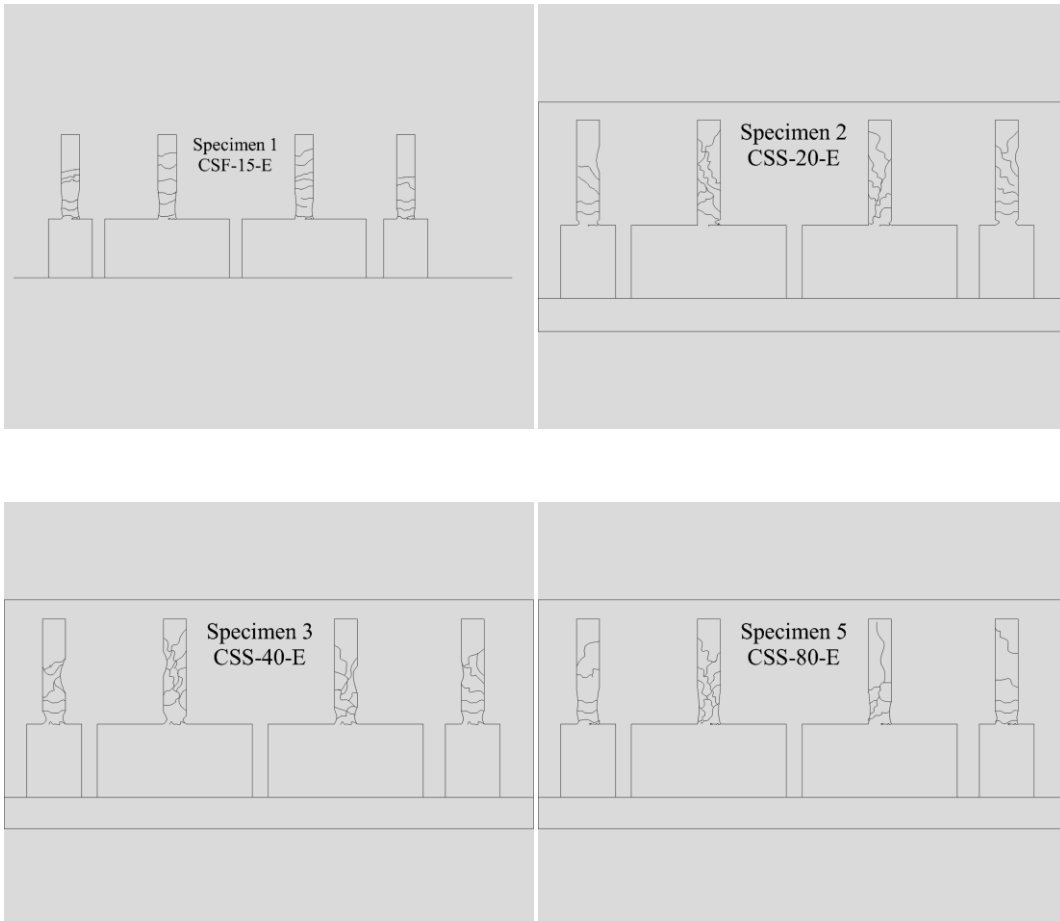
Figure 5.194: Crack pattern at  $(3.73 \Delta y)$  lateral displacement

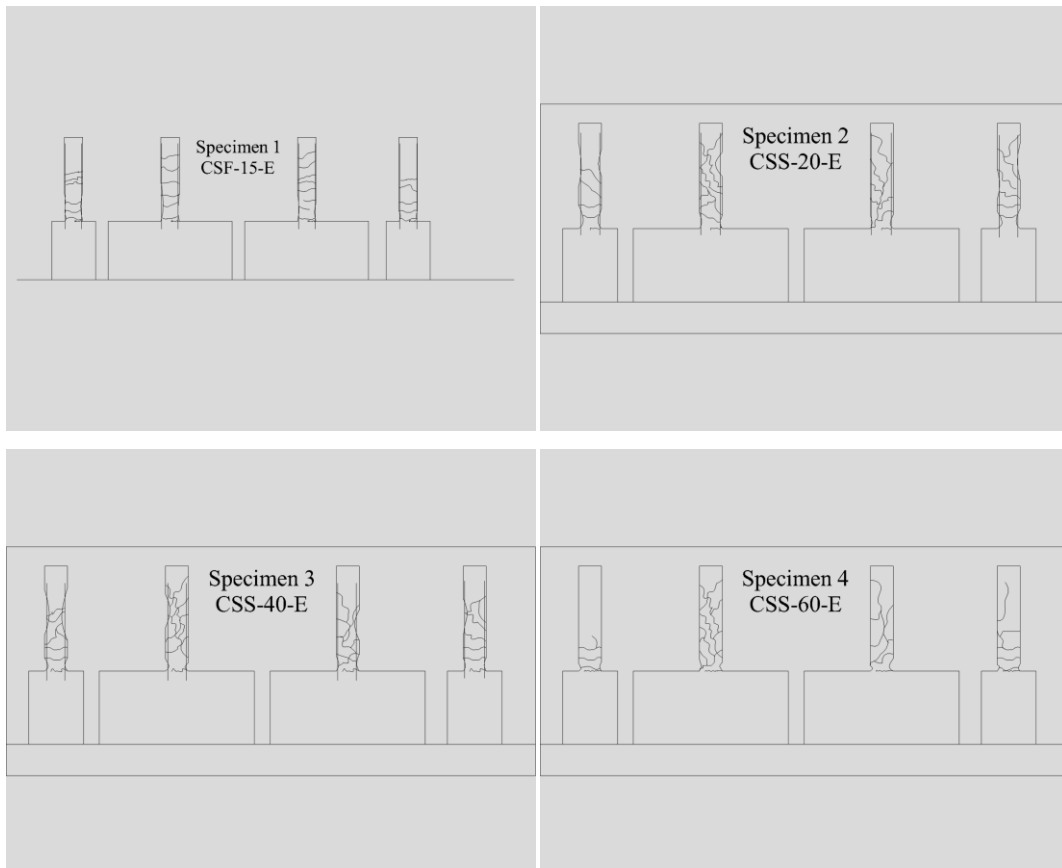
Figure 5.196: Crack pattern at (end of the test) lateral displacement

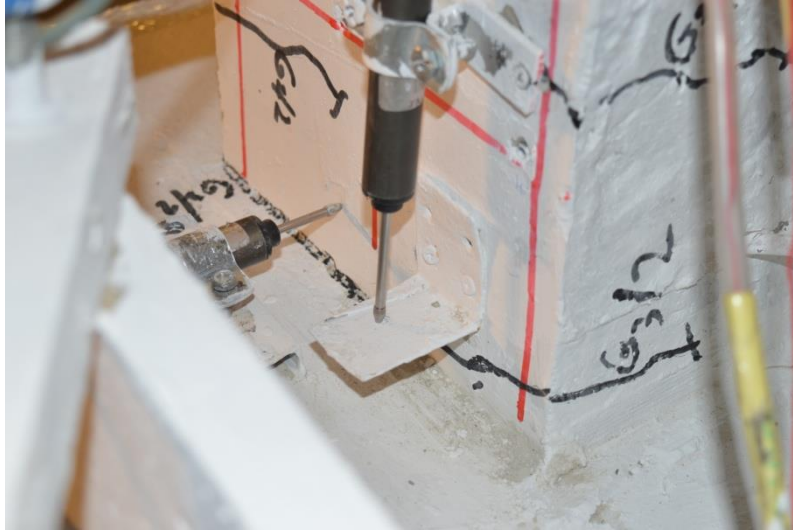
Figure 5.198: CSF-15-E starting slipping from base of column at  $0.5\Delta y$

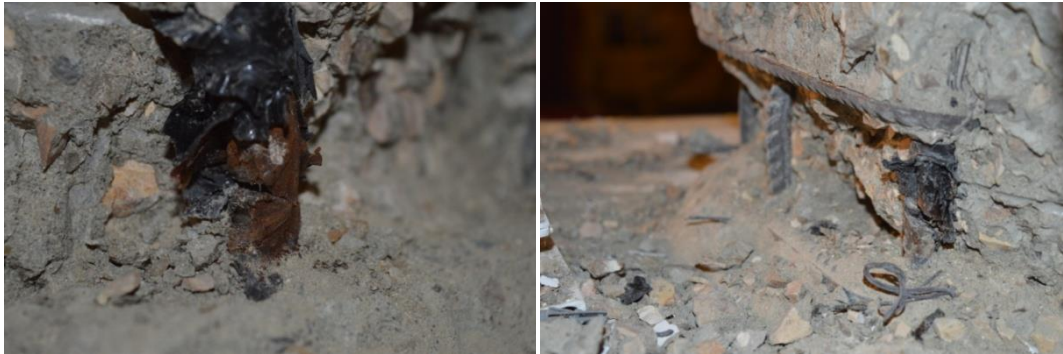
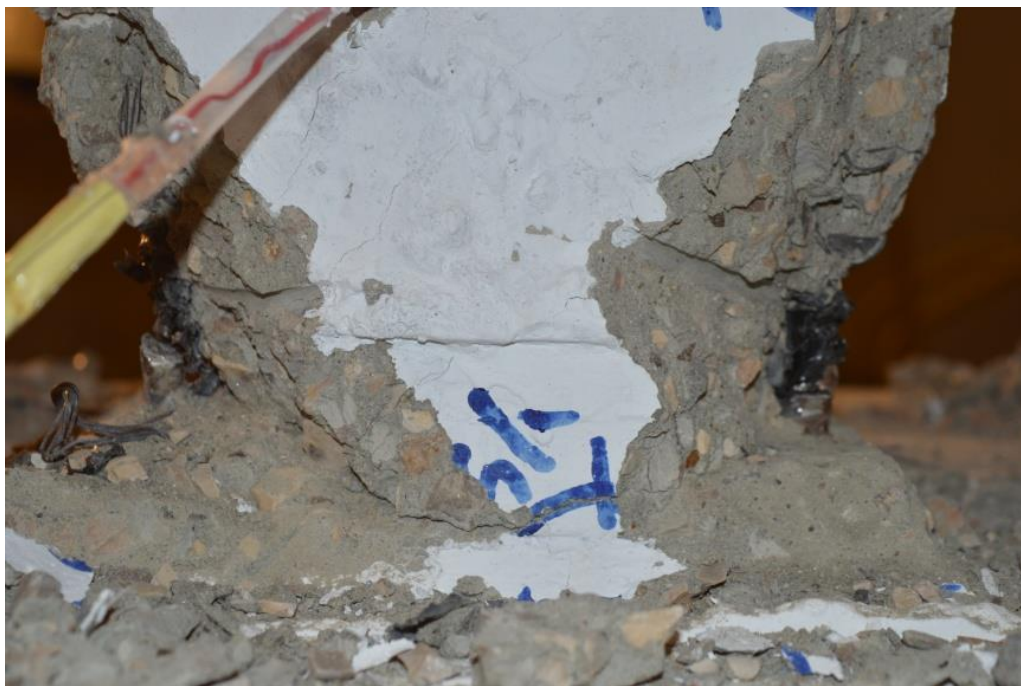
Figure 5.202: Classical tension failure  $4.8\Delta y$

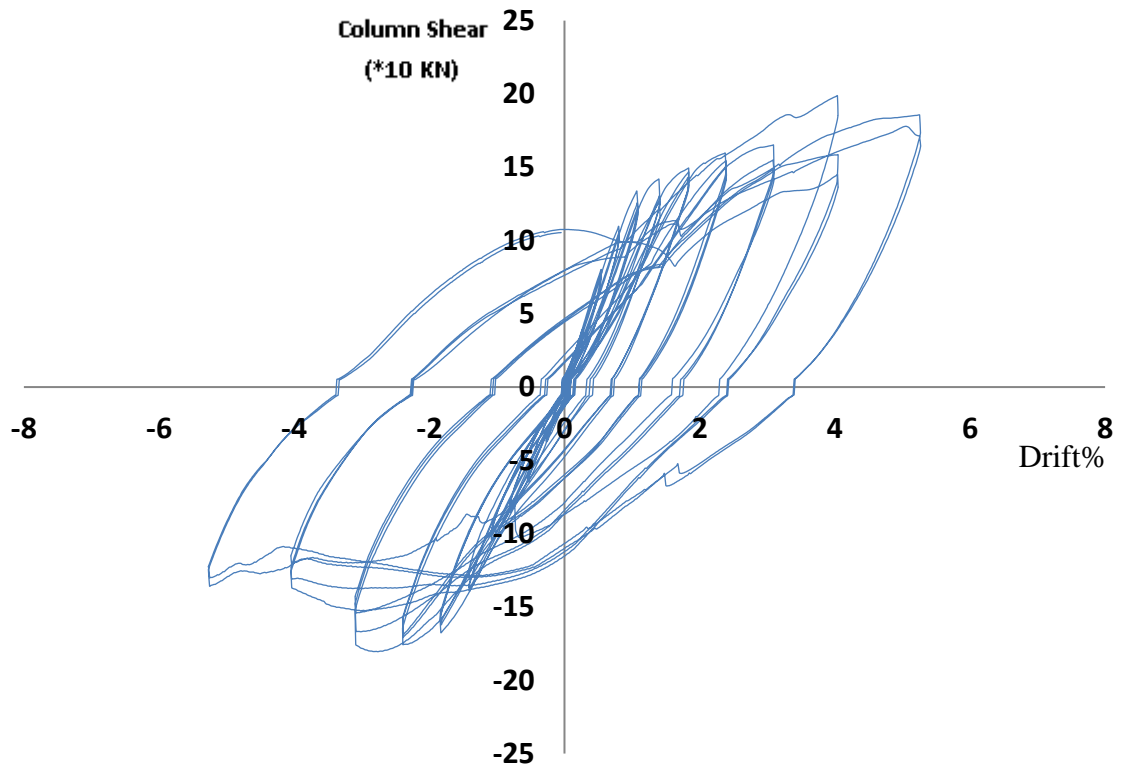
Figure 5.203: Shear force-drift hysteresis response of specimen CSF 15-E

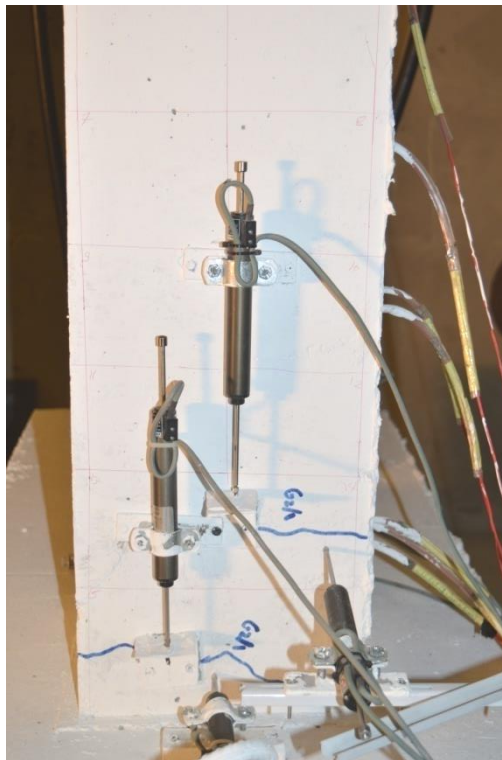
**Figure 5.218: Specimen CSF-80-E at initial cracking ( $0.5 \Delta y$ )**

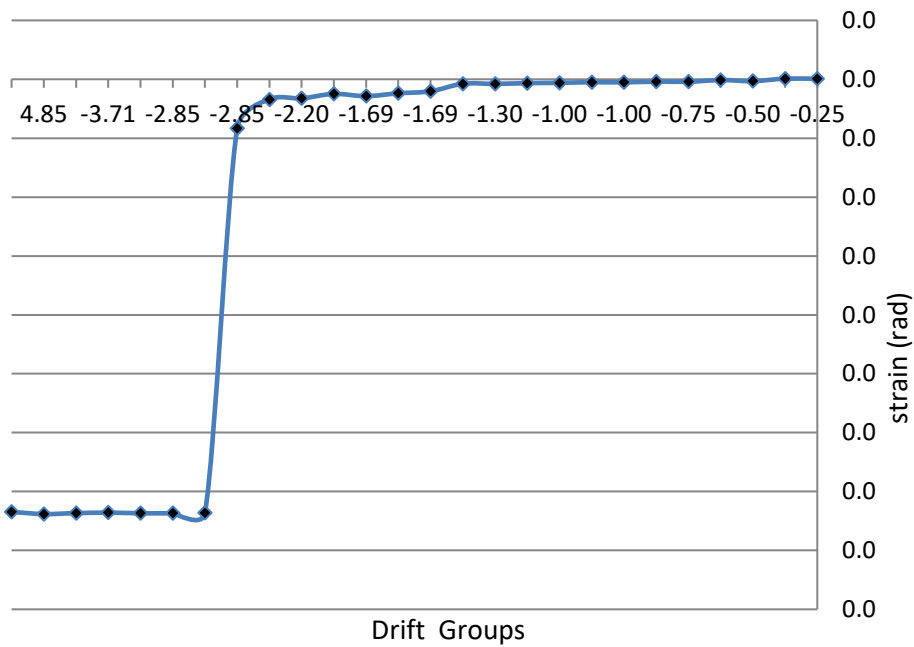
**Figure 5.238: CSF-80-E Tension shear strain (rad) Vs Drift groups (vertical LVDTs 5-12) (tension side)**

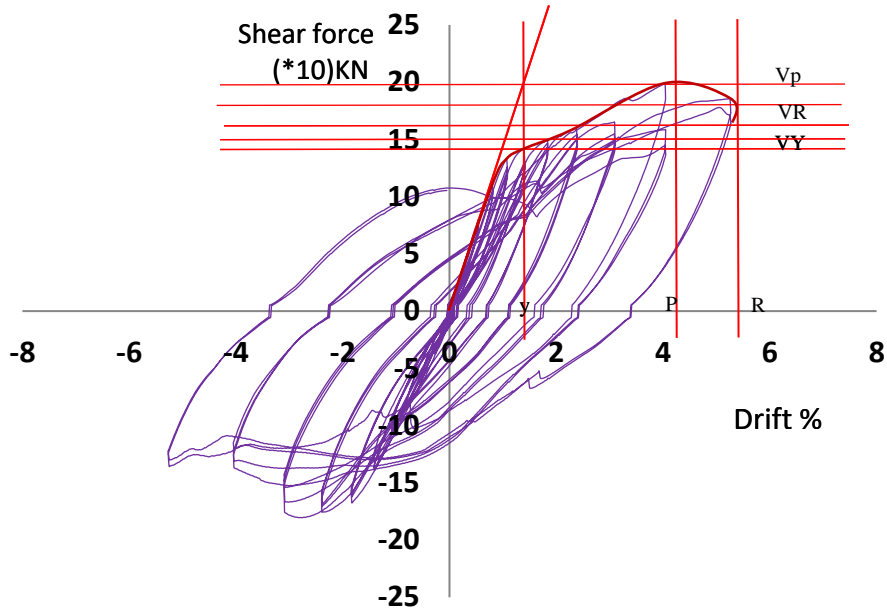
Figure 5.239: Specimen CSF 15 – E output curve data

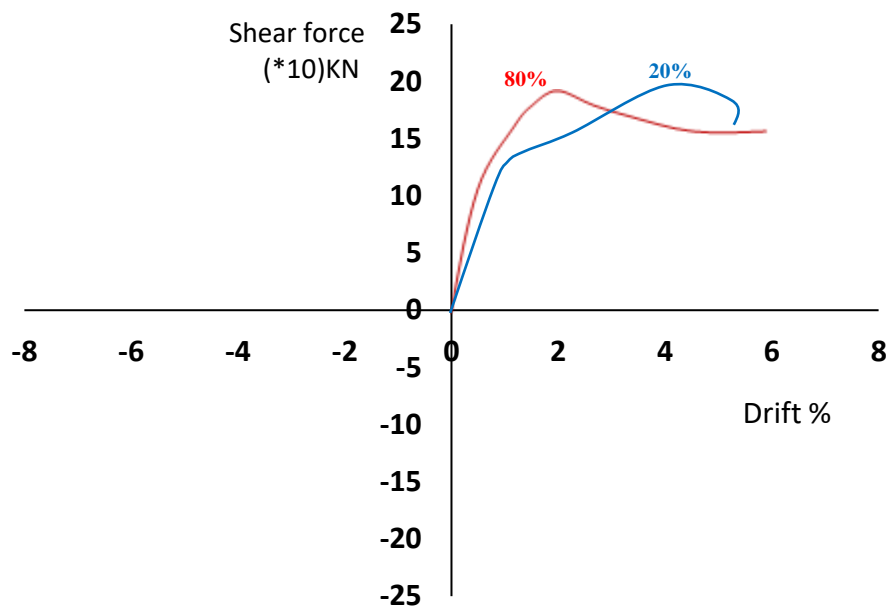
Figure 5.241: Envelope curves

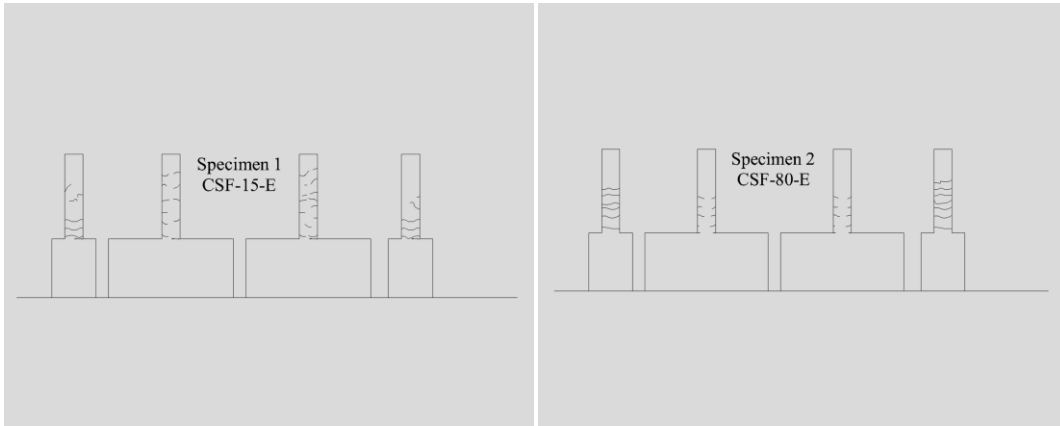
Figure 5.242: Crack pattern at ( $\Delta y$ ) lateral displacement

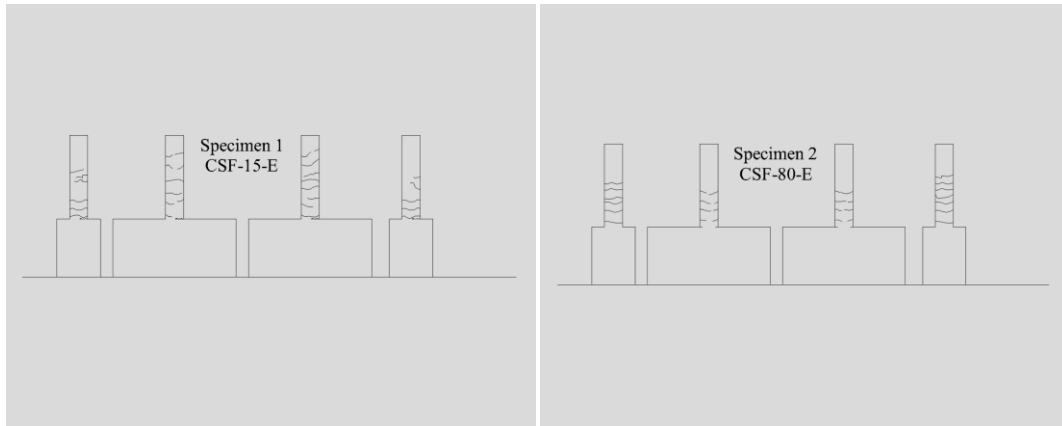
Figure 5.243: Crack pattern at ( $1.3 \Delta y$ ) lateral displacement

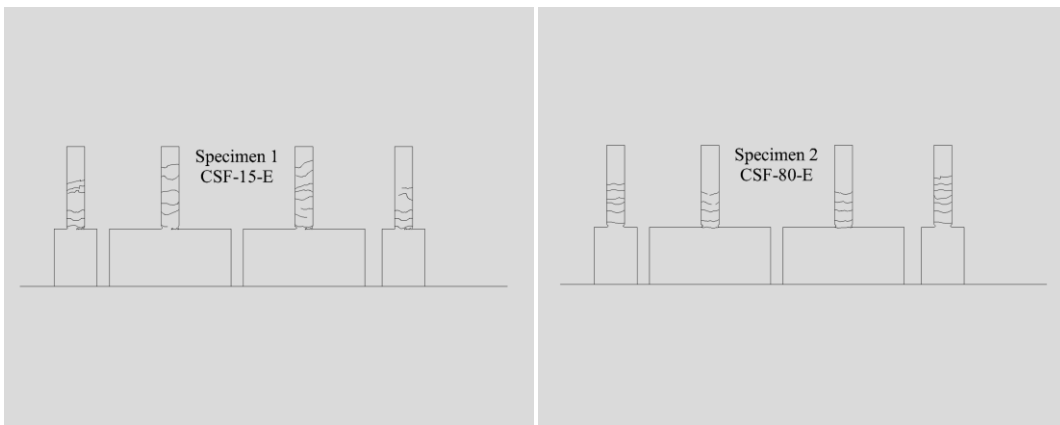
Figure 5.244: Crack pattern at ( $2.2 \Delta y$ ) lateral displacement

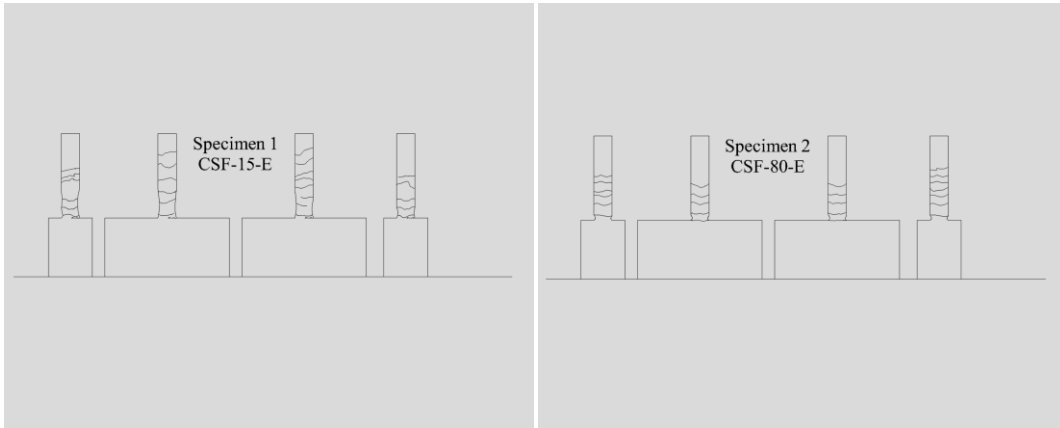
Figure 5.245: Crack pattern at (3.73  $\Delta y$ ) lateral displacement

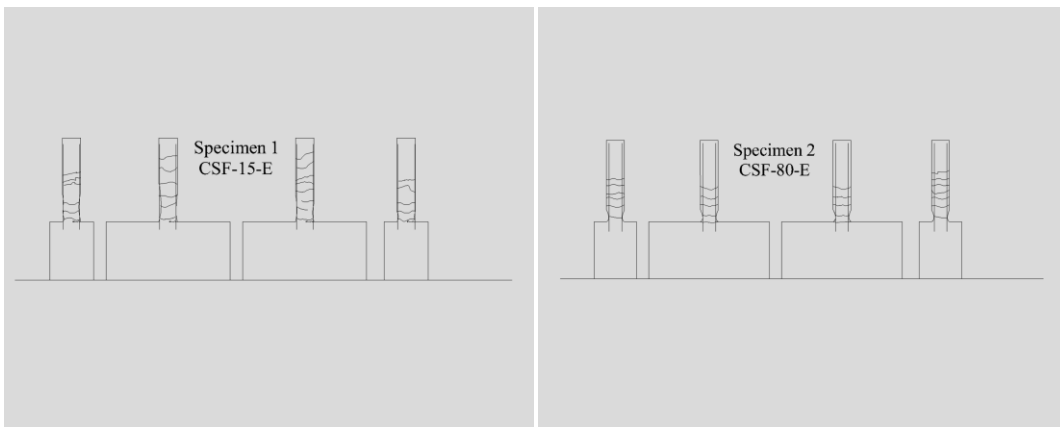
Figure 5.246: Crack pattern at (4.87  $\Delta y$ ) lateral displacement

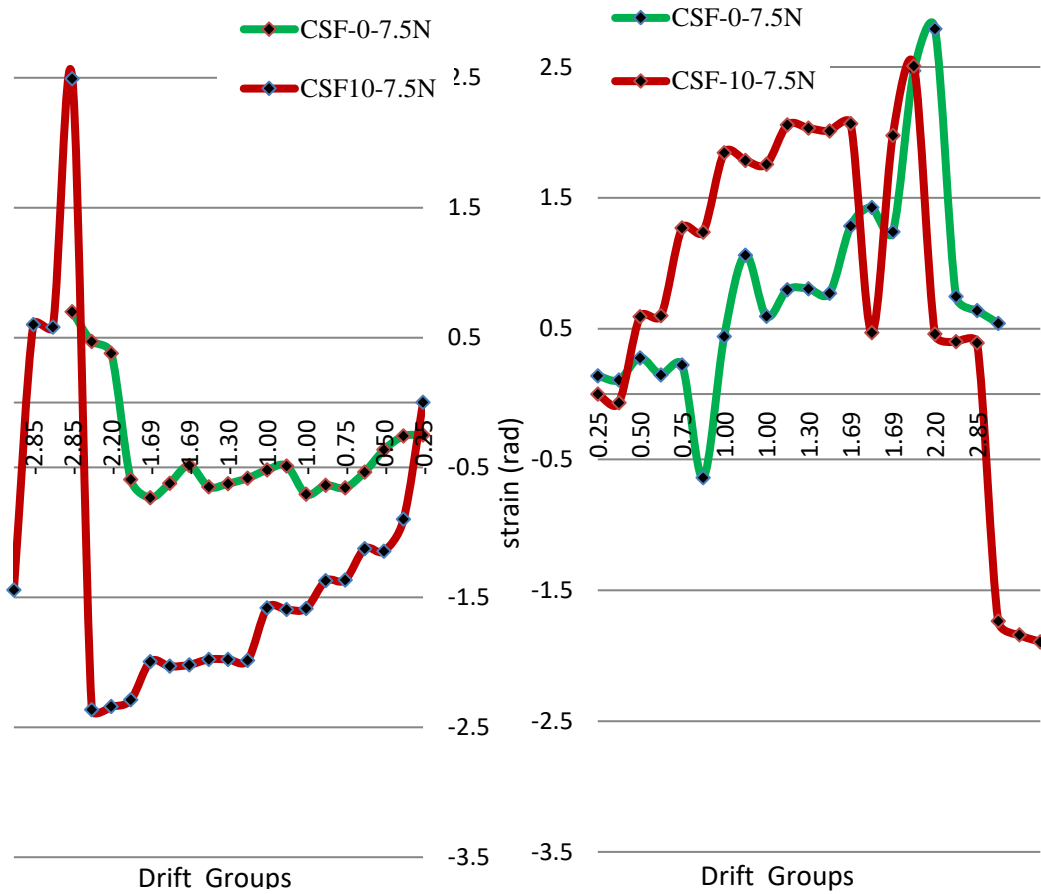
- Increasing axial load ratio from 0% to 10% increase crack wide in CSF10-7.5N in compression loading direction than CSF-0-7.5N. Otherwise, CSF-0-7.5N had a wider crack in tension loading direction than CSF-10-7.5N.

**Figure 6.5: Compression and tension flange steel strain Vs Drift groups (125mm) (axial load effect)**

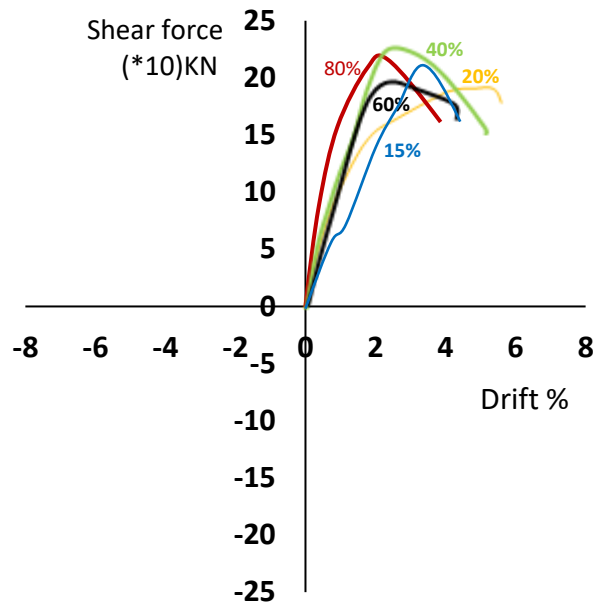
Figure 6.12: Shear deficient old building specimens Backbone curves

- Increasing axial load ratio from 15% to 80% Decreased the drift Capacity gradually from Specimen CSS-15-E to CSS-80-E

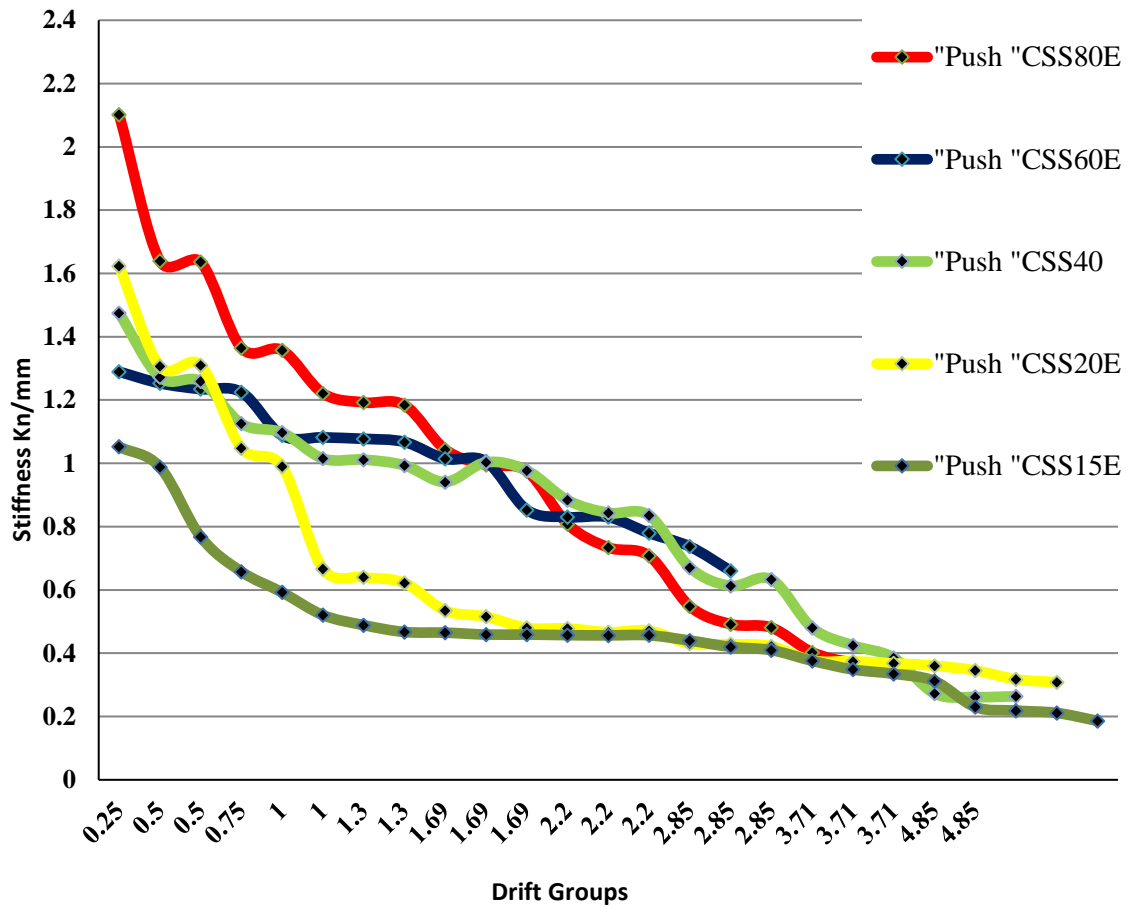
Figure 6.13: Peak to Peak stiffness of shear old building specimens  
(push direction)

- Increasing axial load ratio from 15 % to 80% doubled the peak stiffness in compression direction. In CSS-15-E reach to about 1 Kn/ mm and with increasing load to 80% ratio CSS-80-E reach to 2.1 Kn/mm stiffness.

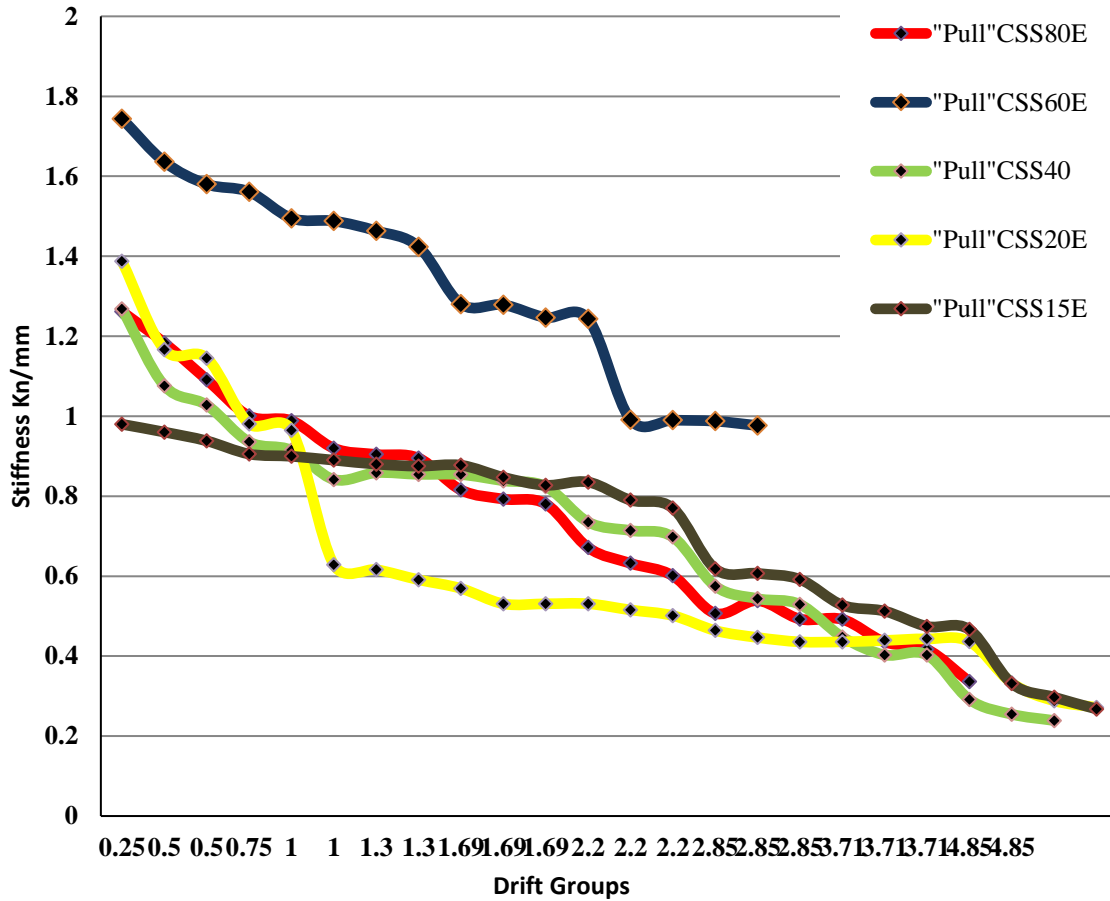
**Figure 6.14: Peak to Peak stiffness of shear old building specimens (pull direction)**

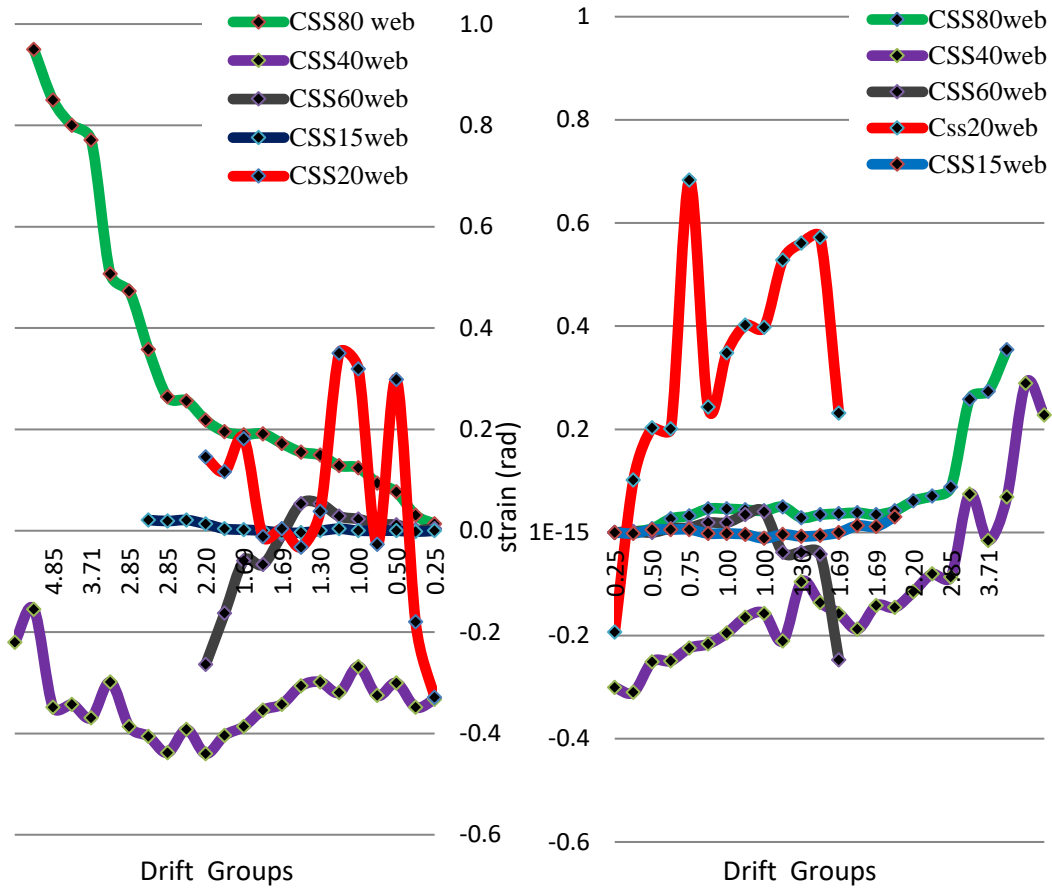
Figure 6.15: Compression and tension Web steel strain Vs Drift groups (320mm)
