### Seismic performance of steel-reinforced concrete composite columns of older and modern construction

**Seismic Performance of Steel-Reinforced concrete Composite  
Columns of Older and Modern Construction**

**Masters of Science in Construction Engineering**

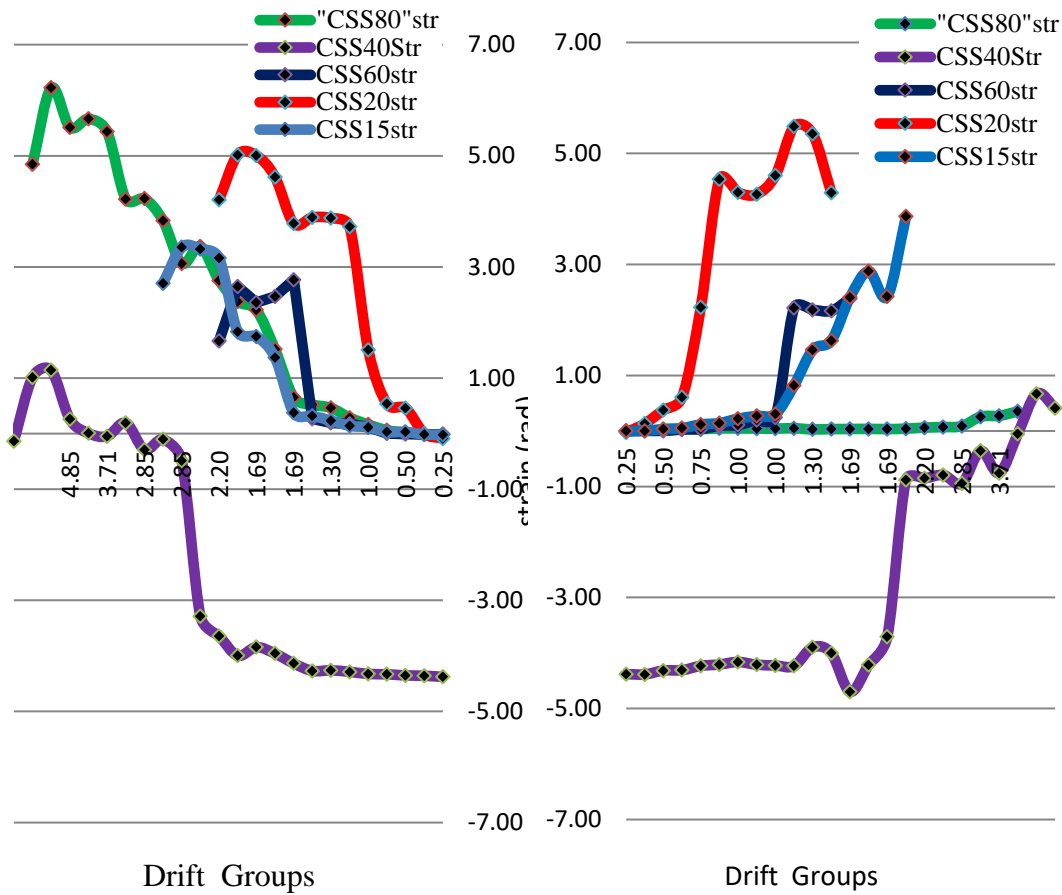
Figure 6.16: Compression and tension steel hoop strain Vs Drift groups (325 mm)

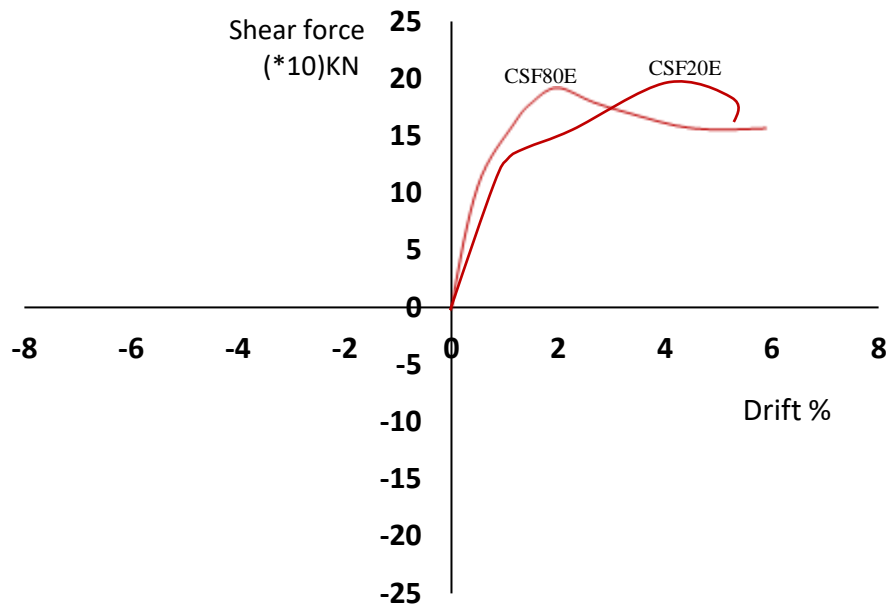
Figure 6.17: Shear deficient old building specimens Backbone curves

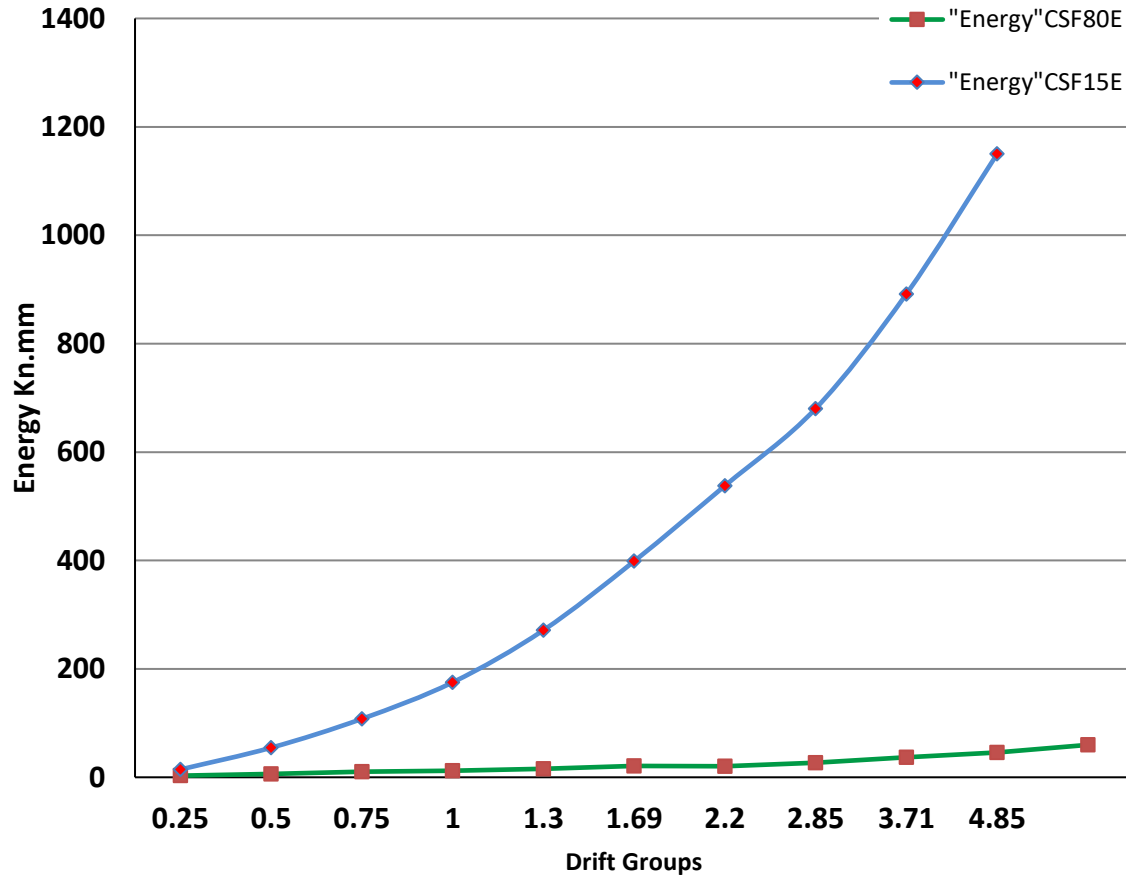
Figure 6.18: Peak to peak Energy of flexure old building specimens

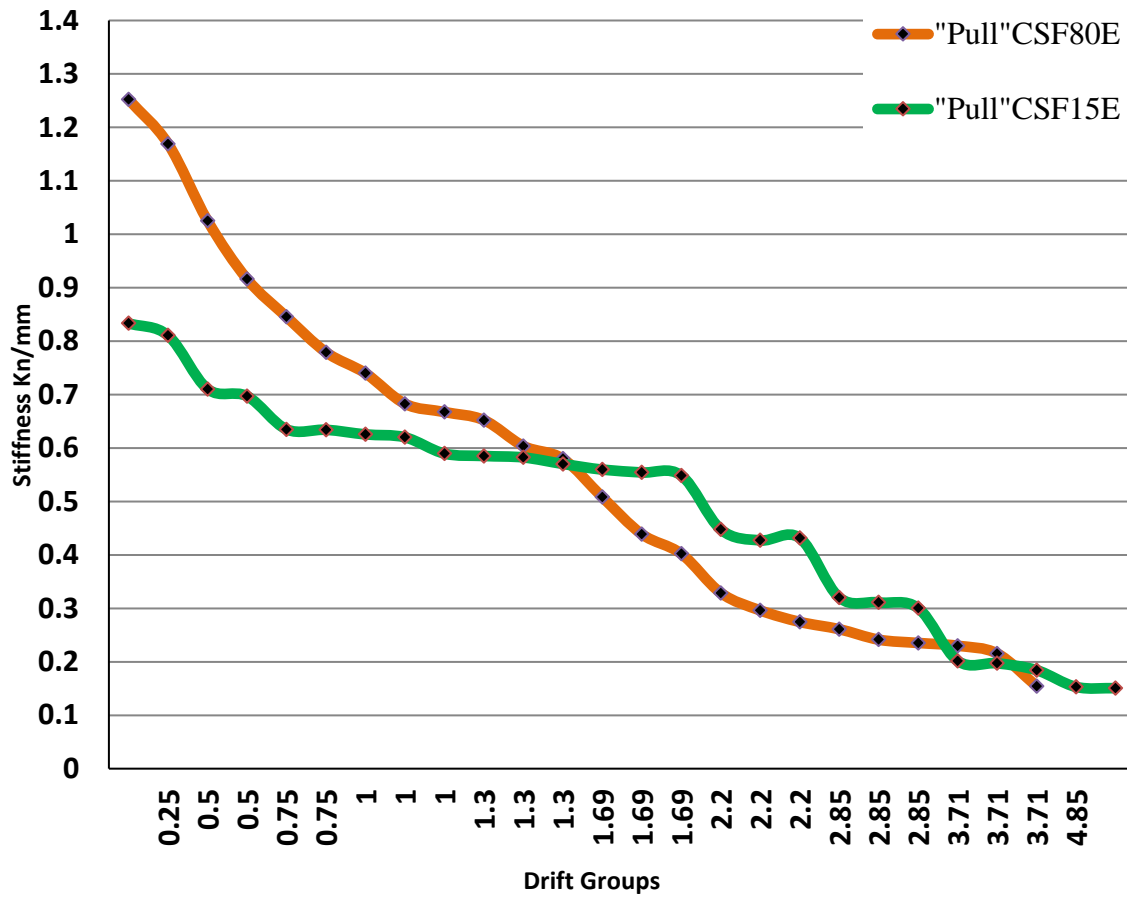
Figure 6.19: Peak to Peak stiffness of flexure old building specimens  
(pull direction)

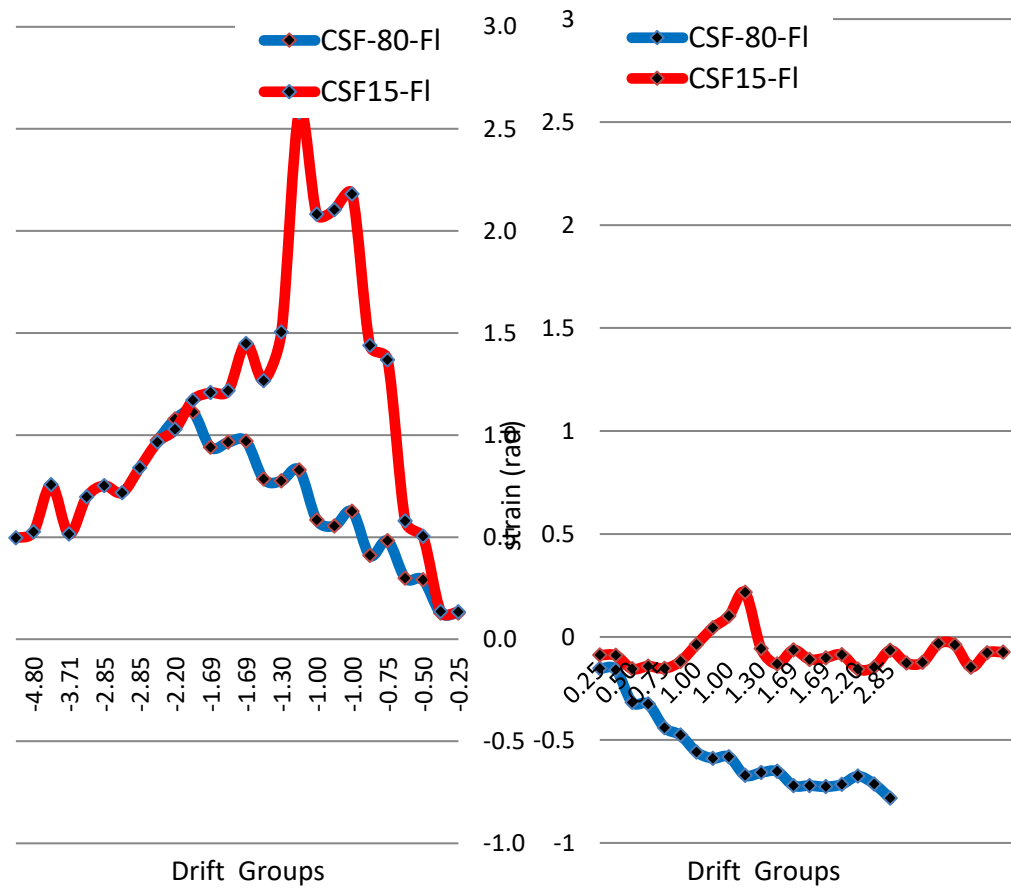
Figure 6.21: Compression and tension flange steel strain Vs Drift groups (300mm)
